Port Orchard Marina  
Underwater Inspection of Marine Facilities  
707 Sydney Parkway, Port Orchard, WA 98366

Prepared by SDS Consultant  
Seattle Diving Services, LLC  
November 2018

# Underwater Inspection of Marine Facilities – Port Orchard Marina

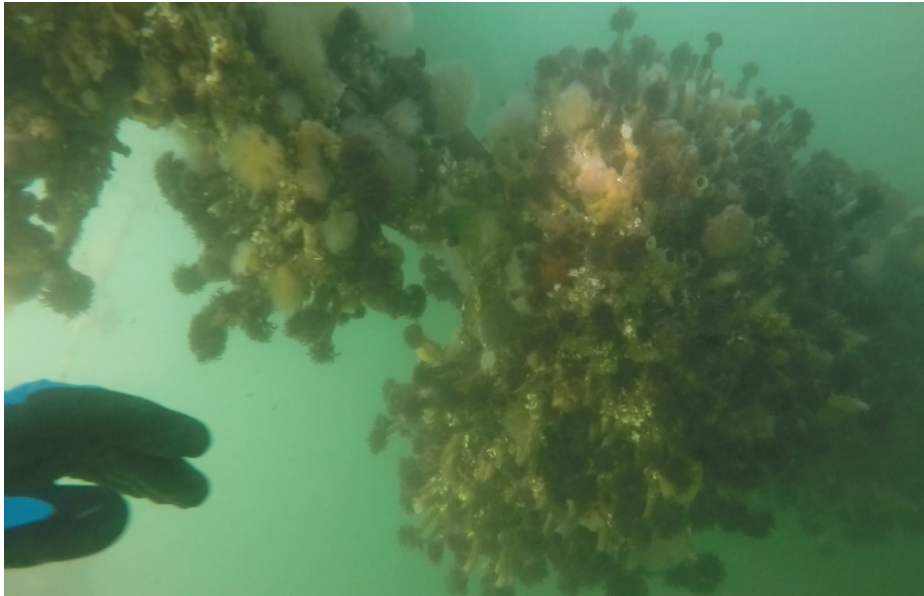
| Seattle Diving Services, LLC | | Photographic log | |
|---|---|---|---|
| Port Orchard Underwater Inspection | | Breakwater | <u>Location</u><br>Mooring Line 47 |

| Seattle Diving Services, LLC | | Photographic log | |
|---|---|---|---|
| <b>Description:</b><br>View of typical marine growth on mooring line 47. | | | |

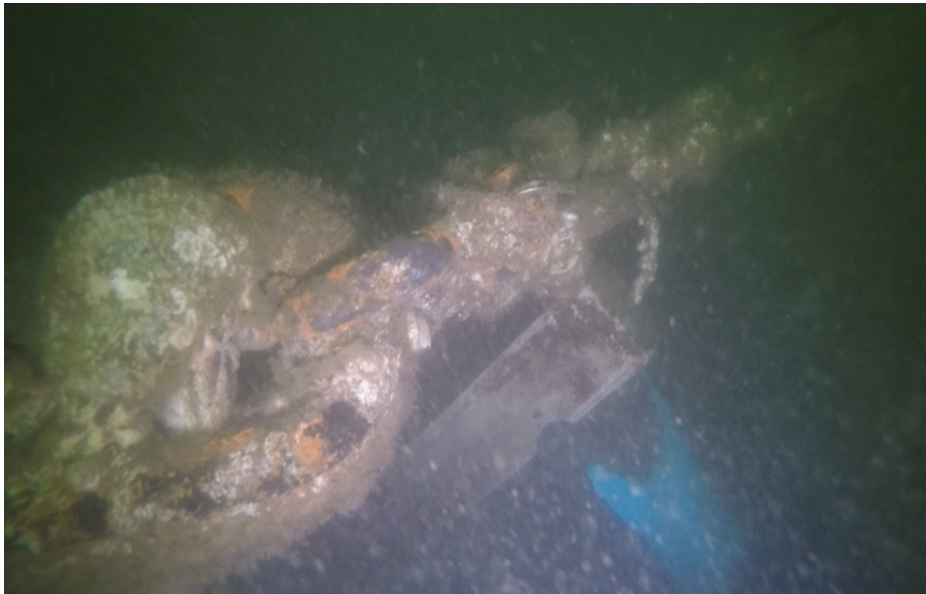
| Seattle Diving Services, LLC | | Photographic log | |
|---|---|---|---|
| Port Orchard Underwater Inspection | | Breakwater | <u>Location</u><br>Mooring Line 20 |

| Seattle Diving Services, LLC | | Photographic log | |
|---|---|---|---|
| <b>Description:</b><br>View of bottom connection corrosion & 90% anode with bad connection on mooring line 20. | | | |

Mooring line numbers 11, 20, 54, 68, & 70 were all observed to have advanced corrosion on the bottom chain and connections. In-kind rehabilitation would involve one additional anode installed at the top of the bottom chain and include proper cleaning sufficient enough to ensure contact between the bottom chain and cathodic protection. These repairs need to be carried out with moderate urgency. Mooring lines and cathodic protection components should continue to be inspected annually. All anodes 50% or below should be considered for replacement within the next two quarters. Continued annual inspection should be considered for future planning.

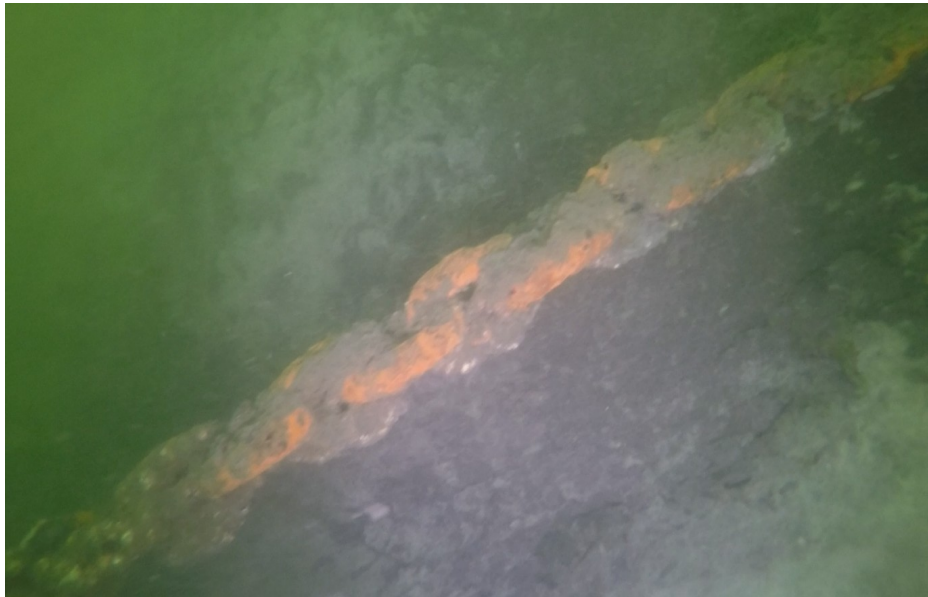
| Seattle Diving Services, LLC | | Photographic log | |
|---|---|---|---|
| Port Orchard Underwater Inspection | | Breakwater | <u>Location</u><br>Mooring Line 11 |

| Seattle Diving Services, LLC | | Photographic log | |
|---|---|---|---|
| <b>Description:</b><br>View of bottom chain<br>advanced corrosion<br>on mooring line L-11. | | | |

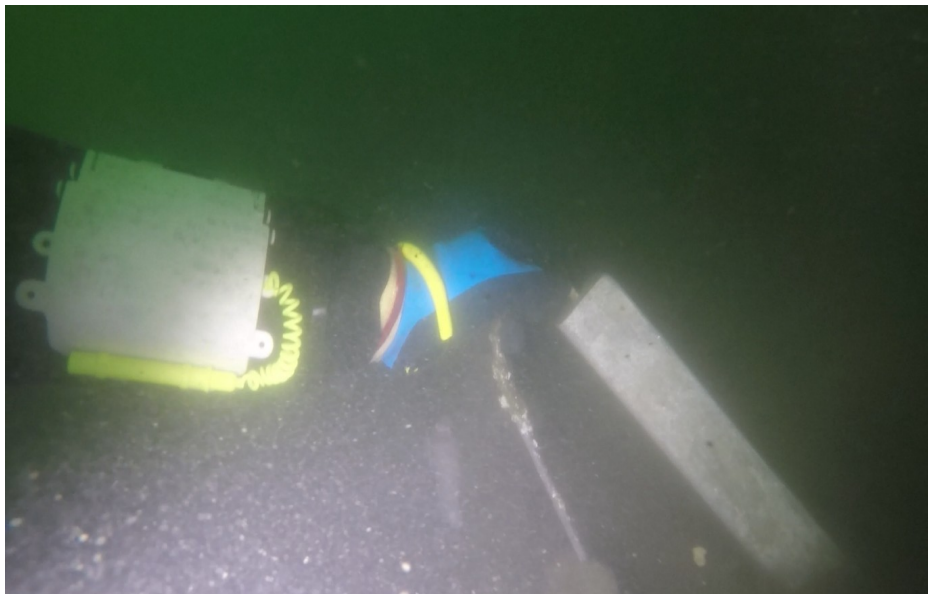
| Seattle Diving Services, LLC | | Photographic log | |
|---|---|---|---|
| Port Orchard Underwater Inspection | | Breakwater | <u>Location</u><br>Mooring Line 50 |

| Seattle Diving Services, LLC | | Photographic log | |
|---|---|---|---|
| <b>Description:</b><br>View of 100% anode disconnected on bottom off mooring line 50.<br>Hardware malfunction. | | | |

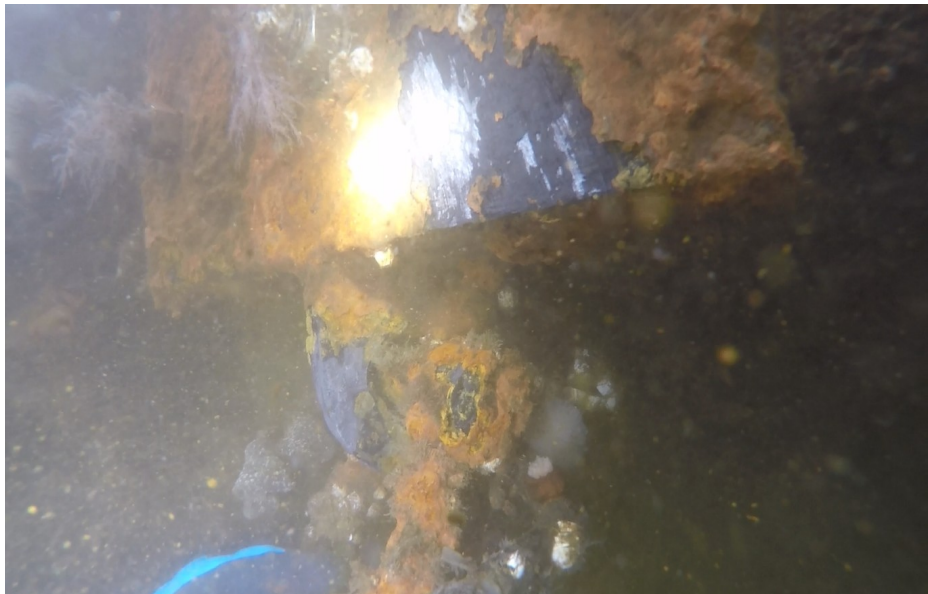
| Seattle Diving Services, LLC | | Photographic log | |
|---|---|---|---|
| Port Orchard Underwater Inspection | | Bridal Chains | <u>Location</u><br>Bridal 11 |

Thirteen bridal chain systems were listed for level II inspection. Fourteen bridal chain systems were found, two of which were disconnected. Mounting brackets for bridle chain numbers 11 & 35 were both subject to advanced deterioration and connection failure. (See Photos 5 & 6) The originating cause behind the failure is suspected to be ordinary wear from the 1" shackle connecting the 5/8" long-link bridle chain to the bracket. Under the influence of waves, currents, and electrochemical corrosion these two components had worn and failed. The lower connection of these bridle chains were still connected to the mooring lines and were found to have advanced deterioration. Early stages of pad-eye wearing was found on bridle chain bracket numbers 19 & 42. (See Photo 7) All other bridle brackets, chains, and associated hardware was in satisfactory condition with minor but typical deterioration. (See Photo 8)

| Seattle Diving Services, LLC | | Photographic log | |
|---|---|---|---|
| <b>Description:</b><br>View of bridal bracket<br>advanced corrosion &<br>chain disconnected<br>on Bridal 11. | | | |

The bridle chain numbers 11 & 35 have brackets that have deteriorated to a point of failure. These brackets and associated bridle chains should be considered for in-kind replacement as soon as possible. New cathodic protection will need to be installed on the bridle chain only.

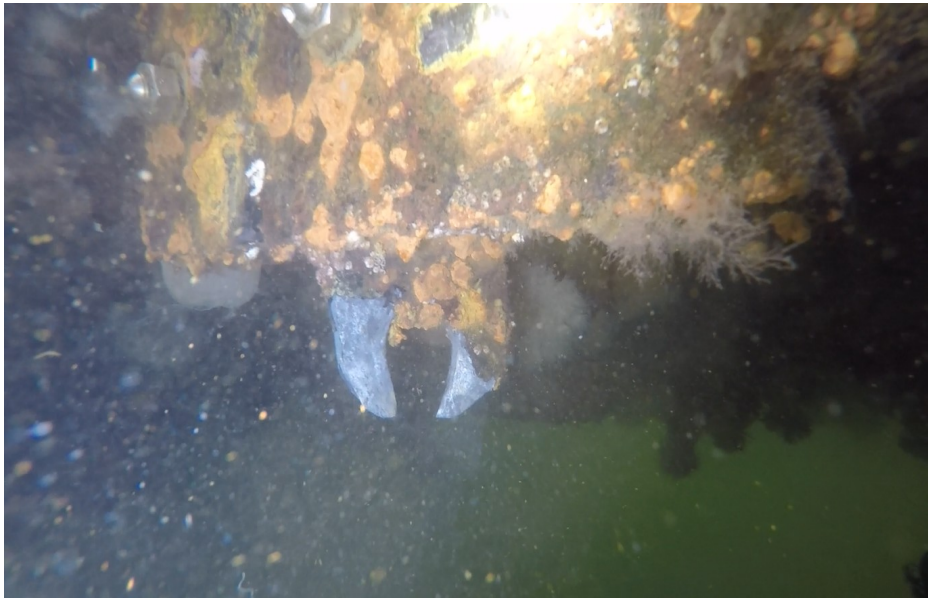
| Seattle Diving Services, LLC | | Photographic log | |
|---|---|---|---|
| Port Orchard Underwater Inspection | | Bridal Chains | <u>Location</u><br>Bridal 35 |

| Seattle Diving Services, LLC | | Photographic log | |
|---|---|---|---|
| <b>Description:</b><br>View of bridal bracket corrosion & hardware failure on Bridal 35. | | | |

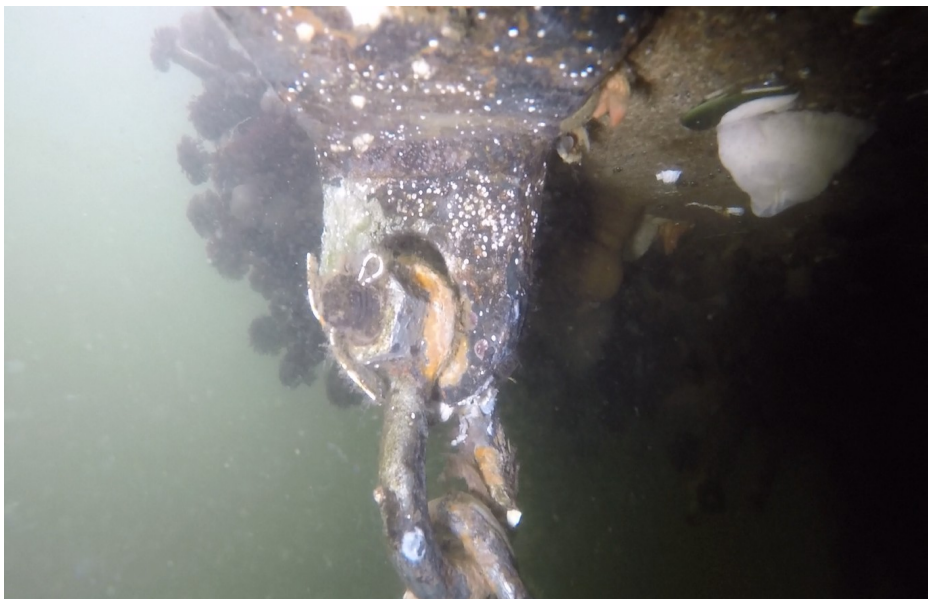
| Seattle Diving Services, LLC | | Photographic log | |
|---|---|---|---|
| Port Orchard Underwater Inspection | | Bridal Chains | <u>Location</u><br>Bridal 19 |

| Seattle Diving Services, LLC | | Photographic log | |
|---|---|---|---|
| <b>Description:</b><br>View of padeye wearing<br>& chafing on Bridal 19. | | | |

Bridle bracket numbers 19 & 42 should be considered for replacement within the next year due to typical wear from wave action.

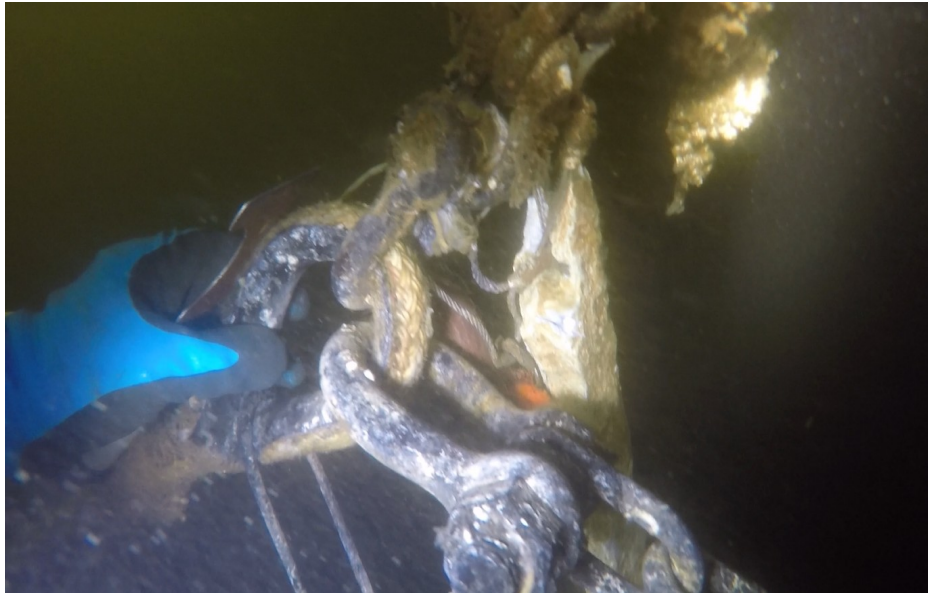
| Seattle Diving Services, LLC | | Photographic log | |
|---|---|---|---|
| Port Orchard Underwater Inspection | | Bridal Chains | <u>Location</u><br>Bridal 61 |

| Seattle Diving Services, LLC | | Photographic log | |
|---|---|---|---|
| <b>Description:</b><br>View of general Bridal conditions & typical minor surface corrosion on bridal 61. | | | |

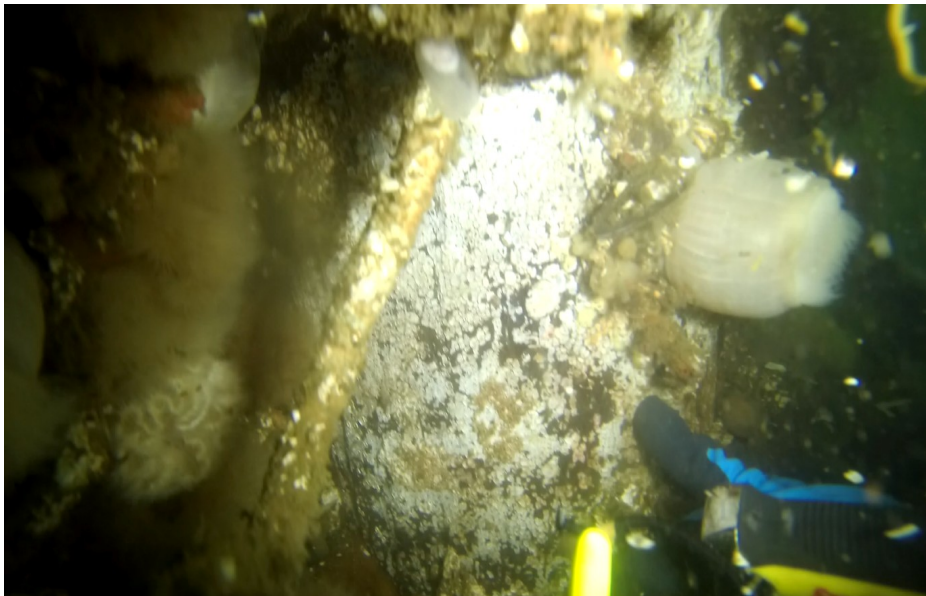
| Seattle Diving Services, LLC | | Photographic log | |
|---|---|---|---|
| Port Orchard Underwater Inspection | | Timber Pile | <u>Location</u><br>Pile #45 |

No major defects or deterioration was found, only minor abrasion in the tidal zone cause by the pile guide was noted. Minor deterioration of the creosote coating was detected but is typical. Hammer soundings determined the pile to be in overall sound condition. Physical examination did not detect any rot, borer holes, or major deterioration, only minimal cracking was discovered. (See Photo 9)

| Seattle Diving Services, LLC | | Photographic log | |
|---|---|---|---|
| <b>Description:</b><br>View of surface area<br>cleaned, no damage.<br>Timber Pile #45. | | | |

No repairs are recommended to the underwater portion of the timber pile. The timber pile is estimated to have approximately 10- 15 years of useful life remaining before replacement or similar repair should be considered.

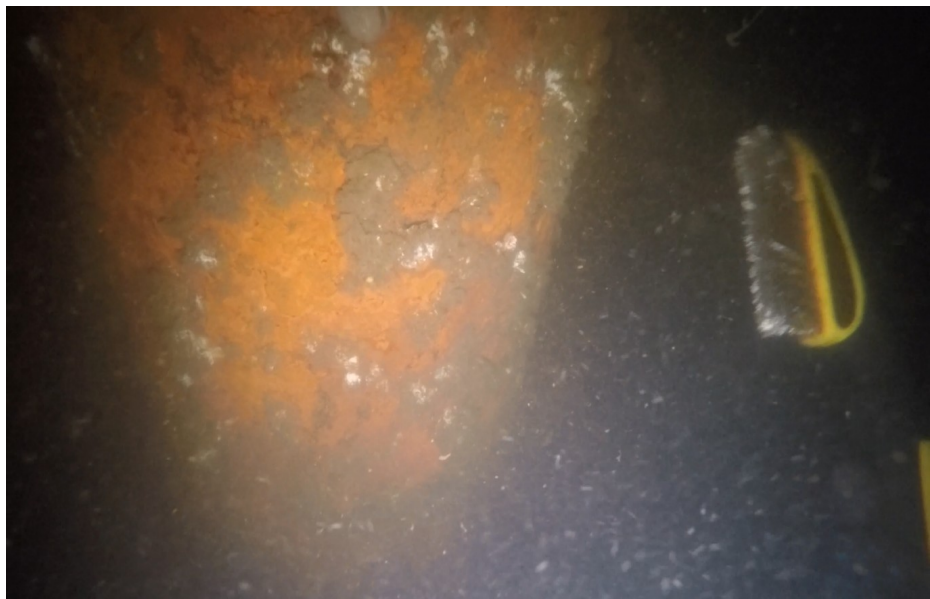
| Seattle Diving Services, LLC | | Photographic log | |
|---|---|---|---|
| Port Orchard Underwater Inspection | | Pilot Piles | <u>Location</u><br>Pile B-1 |

| Seattle Diving Services, LLC | | Photographic log | |
|---|---|---|---|
| <b>Description:</b><br>View of advanced surface corrosion in the submerged zone on B-1. | | | |

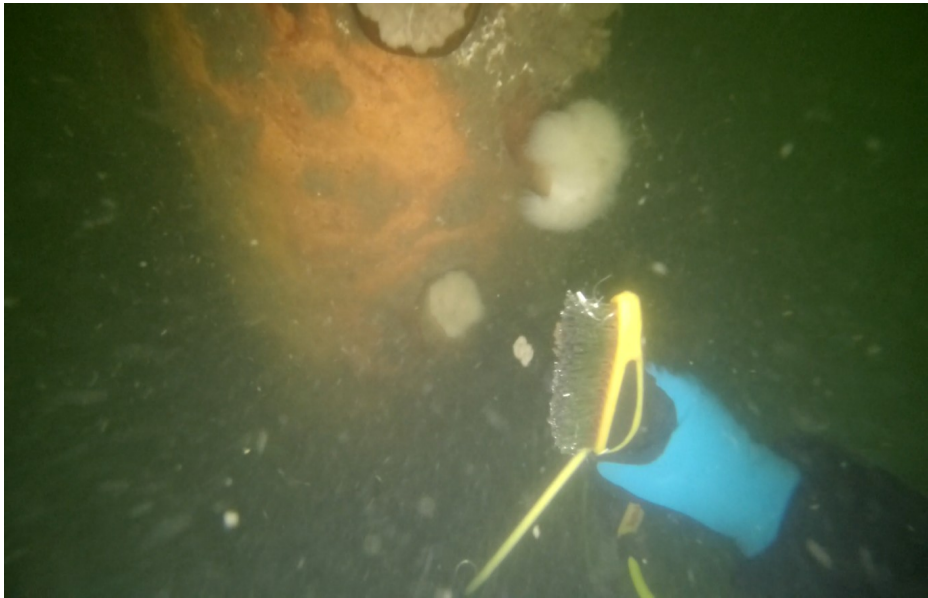
| Seattle Diving Services, LLC | | Photographic log | |
|---|---|---|---|
| Port Orchard Underwater Inspection | | Pilot Piles | <u>Location</u><br>Pile B-6 |

| Seattle Diving Services, LLC | | Photographic log | |
|---|---|---|---|
| <b>Description:</b><br>View of advanced surface corrosion in the submerged zone on Pile B-6. | | | |

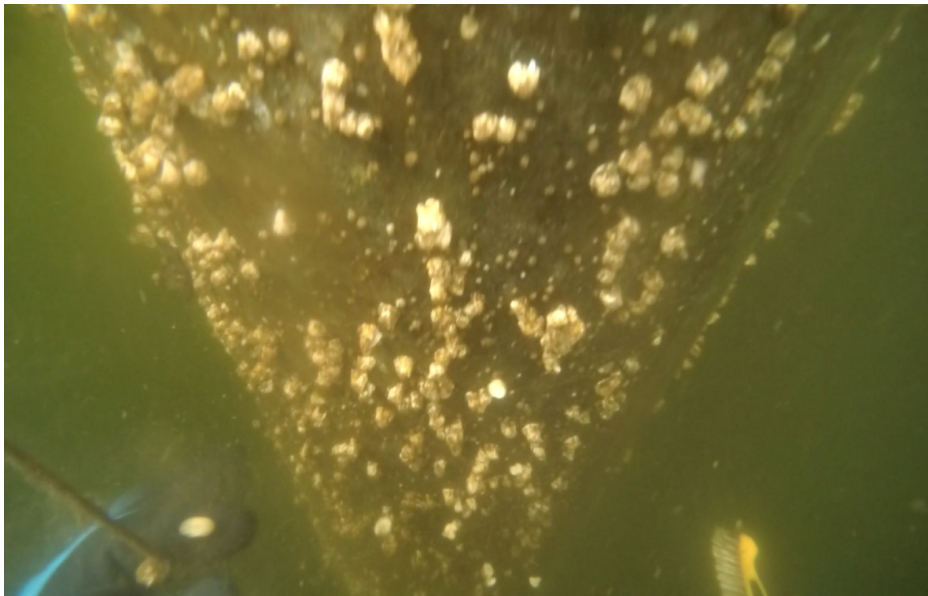
| Seattle Diving Services, LLC | | Photographic log | |
|---|---|---|---|
| Port Orchard Underwater Inspection | | Pilot Piles | <u>Location</u><br>Pile D-32 |

| Seattle Diving Services, LLC | | Photographic log | |
|---|---|---|---|
| <b>Description:</b><br>View of minor corrosion,<br>no advanced surface rust<br>on Pile D-32. | | | |

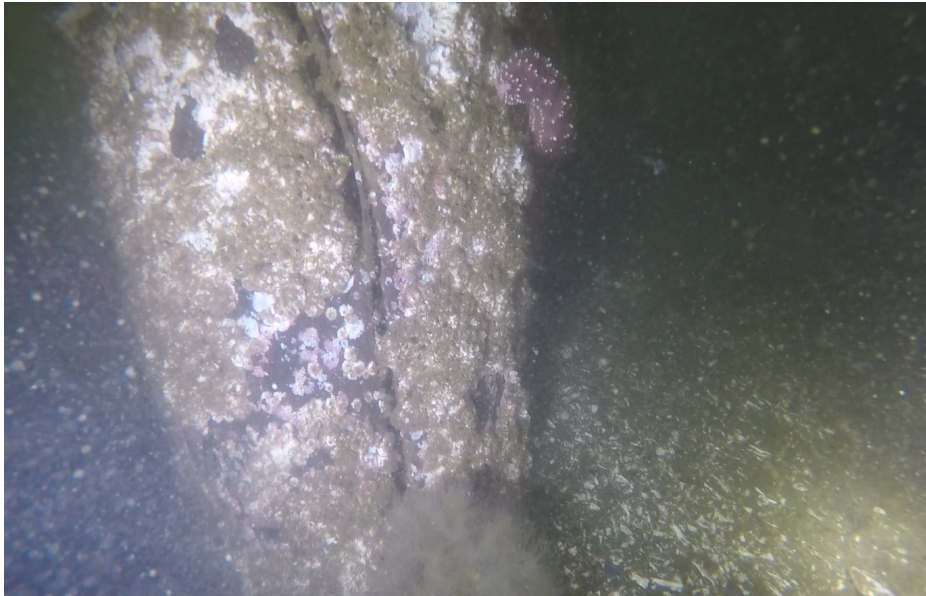
| Seattle Diving Services, LLC | | Photographic log | |
|---|---|---|---|
| Port Orchard Underwater Inspection | | Shoreline Structures & Approach Docks | <u>Location</u><br>G-Dock - NE Pile |

| Seattle Diving Services, LLC | | Photographic log | |
|---|---|---|---|
| <b>Description:</b><br>View of (1"-2") wide crack – (12') long from seabed. | | | |

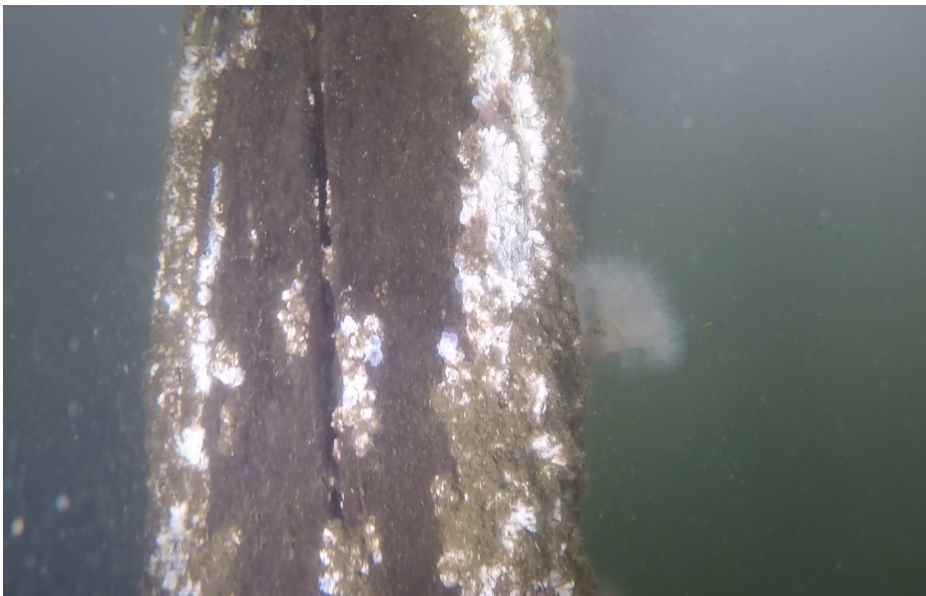
| Seattle Diving Services, LLC | | Photographic log | |
|---|---|---|---|
| Port Orchard Underwater Inspection | | Shoreline Structures & Approach Docks | <u>Location</u><br>G-Dock – NE Pile |

| Seattle Diving Services, LLC | | Photographic log | |
|---|---|---|---|
| <b>Description:</b><br>View of (1"-2") wide crack – (12') long approximately midwater. | | | |

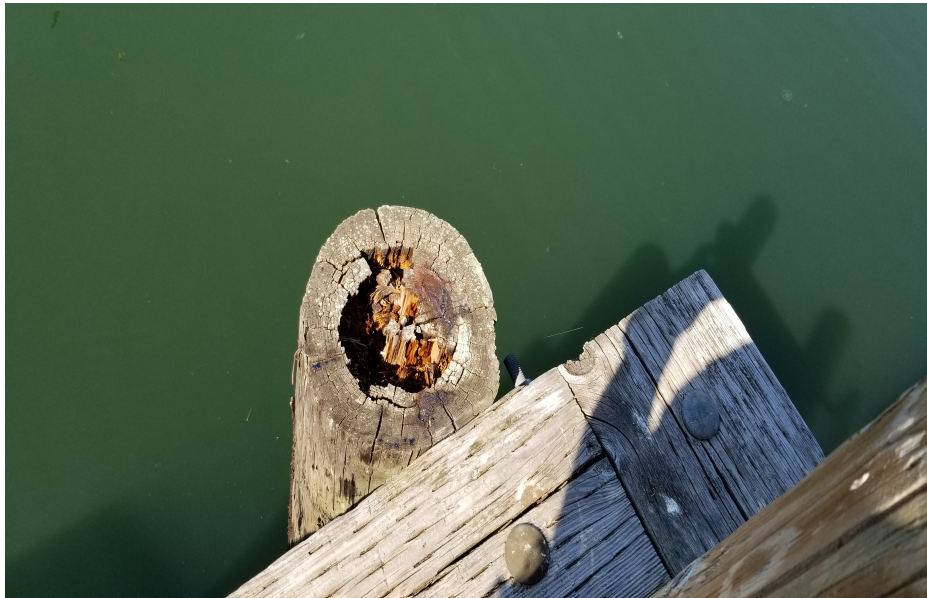
| Seattle Diving Services, LLC | | Photographic log | |
|---|---|---|---|
| Port Orchard Underwater Inspection | | Shoreline Structures & Approach Docks | <u>Location</u><br>G-Dock – NW Pile |

| Seattle Diving Services, LLC | | Photographic log | |
|---|---|---|---|
| <b>Description:</b><br>View of advanced material loss on top of Pile. | | | |
