Port of Bremerton  
Underwater Inspection of Marine Facilities  
120 Washington Beach Ave. Bremerton, WA 98337

Prepared by SDS Consultant  
Seattle Diving Services, LLC  
November 2018

# Underwater Inspection of Marine Facilities – Port of Bremerton

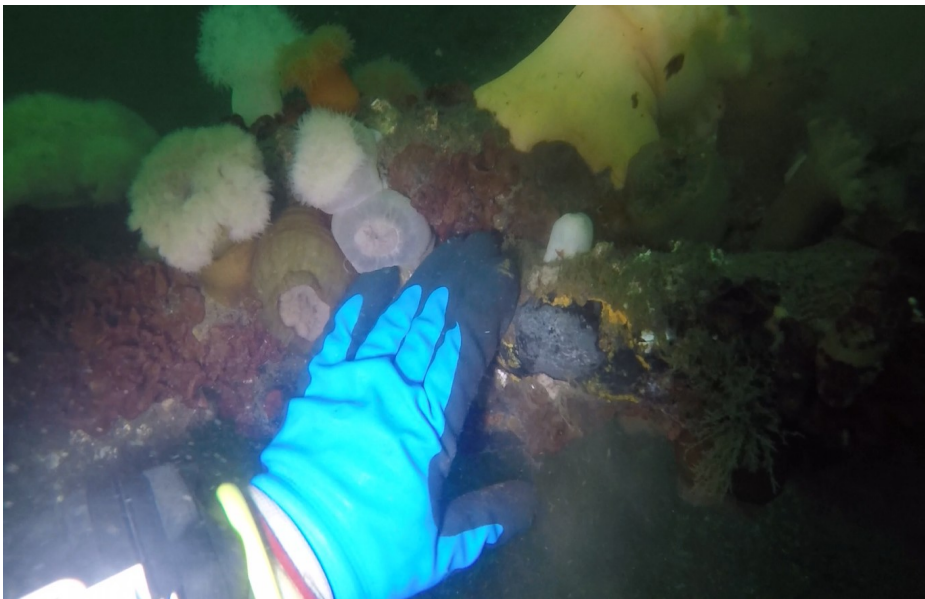
Seattle Diving Services, LLC		Photographic log	
Bremerton Underwater Inspection		Breakwater Mooring Lines	<u>Location</u> Mooring L 20N
Photo 8	Oct. 2018

Floating breakwater mooring lines were found to be in overall satisfactory condition with limited areas of minor deterioration. Mooring line numbers 6S, 20N, & 37 were observed to have minor corrosion such as surface rust on the bottom chain sections, anchor, and connections. (See Photos 8-9) Mooring line numbers 21, 22, & 31N were observed to have minor corrosion such as surface rust on the top chain sections and connections. (See Photo10)

<b>Client:</b> Port of Bremerton Bremerton, Wa.98337			
<b>Description:</b> View of minor surface corrosion on L-20N

Mooring line numbers 6S, 20N, 21, 22 31N, & 37 were observed to have Minor corrosion on the top or bottom chains. In-kind rehabilitation would involve one anode installation on the corresponding chain section and include proper cleaning sufficient enough to ensure contact between the bottom chain and cathodic protection. These repairs should be carried out with moderate urgency.

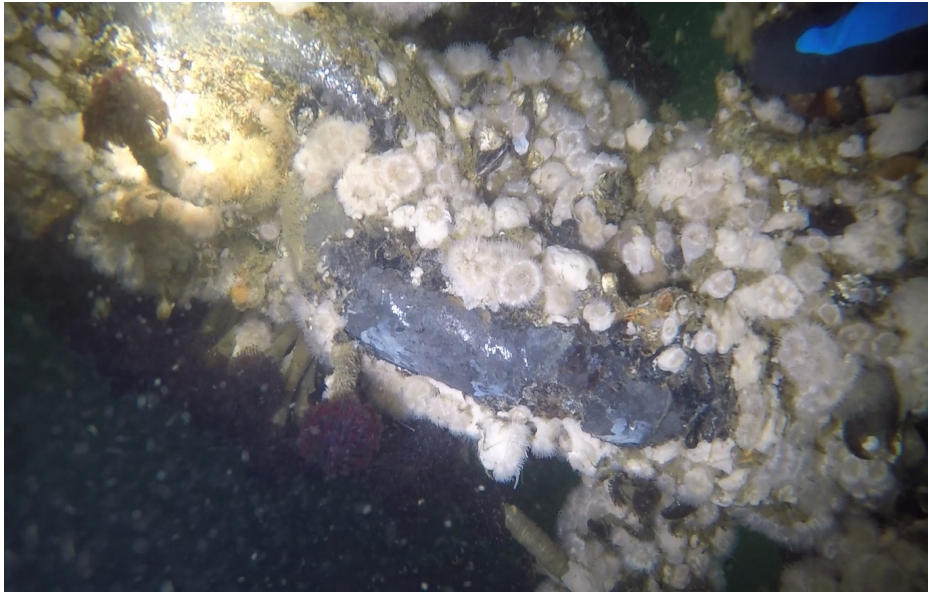
Seattle Diving Services, LLC		Photographic log	
Bremerton Underwater Inspection		Breakwater Mooring Lines	<u>Location</u> Mooring Line L-22
Photo 10	Oct. 2018

<b>Client:</b> Port of Bremerton Bremerton, Wa.98337			
<b>Description:</b> View of minor surface corrosion on top chain Mooring L-22.

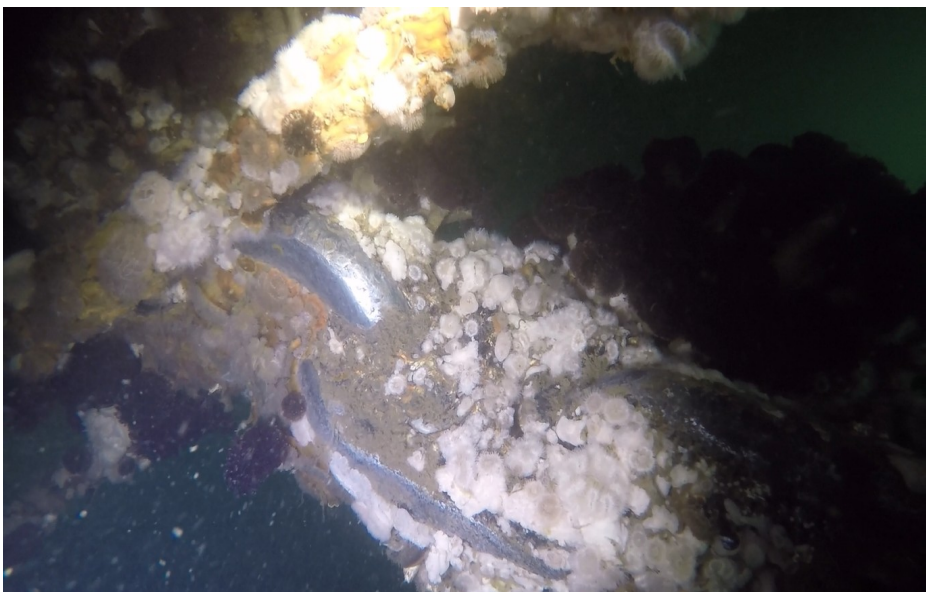
Seattle Diving Services, LLC		Photographic log	
Bremerton Underwater Inspection		Breakwater Mooring Lines	<u>Location</u> Mooring Line L-32
Photo 11	Oct. 2018

No surface corrosion was observed as previously installed anodes appeared to be providing residual protection but this should be considered temporary. The majority of top chain sections with opposing mooring lines showed signs of fretting & minor wear caused from tide fluctuations and wave action from movement of the breakwater. (See Photo11)

<b>Client:</b> Port of Bremerton Bremerton, Wa.98337			
<b>Description:</b> View of chafing of top chain on mooring line L-32.

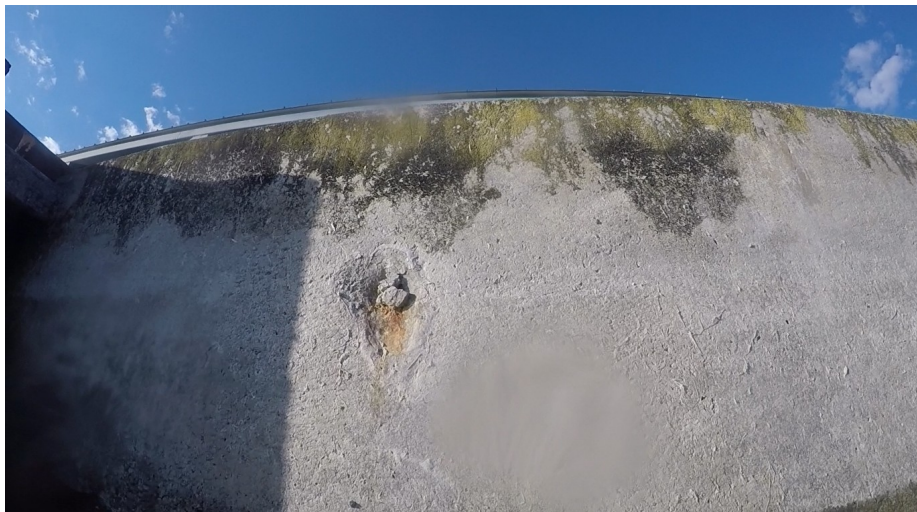
Seattle Diving Services, LLC		Photographic log	
Bremerton Underwater Inspection		Wave Attenuator Wall	<u>Location</u> South Seawall
Photo 12	Oct. 2018

The concrete is generally in overall sound condition with limited areas of minor deterioration. Twenty – 4”x7” areas on the north-side of the wave attenuator wall were subject to cracking and spalling. These areas are suspected to be “pick-points” during installation as they are all in the same locations on each wall, same dimensions, and there is some minor rust staining coming through the concrete protective patches. (See Photo12) All patches are on the north-side of the wall section, just above the high tide line.

<b>Client:</b> Port of Bremerton Bremerton, Wa.98337			
<b>Description:</b> View of typical wall patch deterioration on north side of seawall

The concrete patches on the North-side of the wave attenuator wall are cracking and spalling. It is recommended the failing patches be removed and new patches be installed. The wall support welded to the H-Pilings are progressively deteriorating and recommended that cathodic protection be installed on each H-Piling. Repairs should be carried out within the next year.

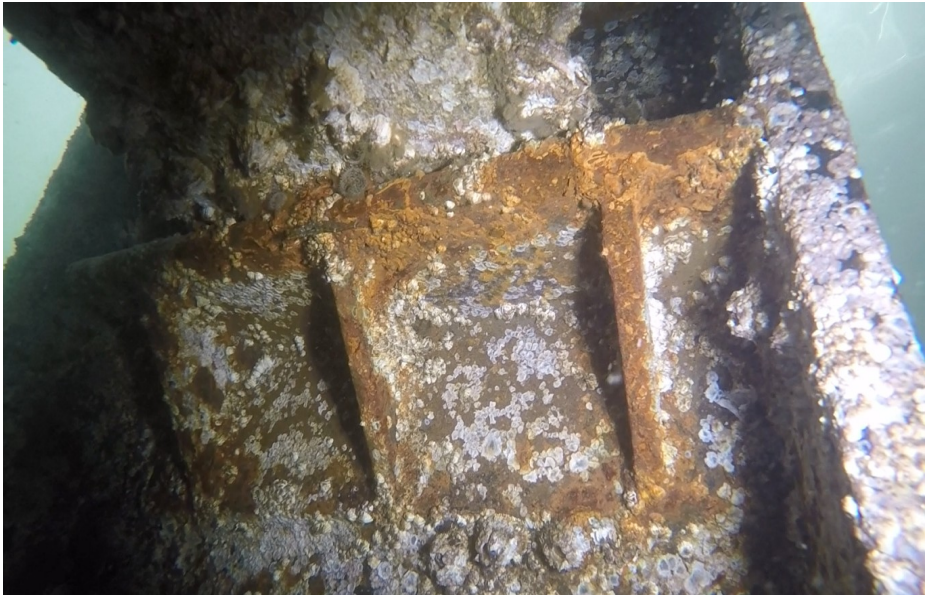
Seattle Diving Services, LLC		Photographic log	
Bremerton Underwater Inspection		Wave Attenuator Wall	<u>Location</u> South Seawall
Photo 14	Oct. 2018

The H-Pilings are in overall fair condition, deterioration was most severe just above the high tide line. (See Photo13) In addition, all wall supporting components welded to the H-Pilings were subject to accelerated deterioration. This form of corrosion is common and is caused when two dissimilar and joined together and submerged. One metal will corrode faster than the other and in this case, it is the wall bracing and supports. The H-Pilings themselves have typical-moderate deterioration. (See Photos 14-15)

<b>Client:</b> Port of Bremerton Bremerton, Wa.98337			
<b>Description:</b> View of typical wall support corrosion.

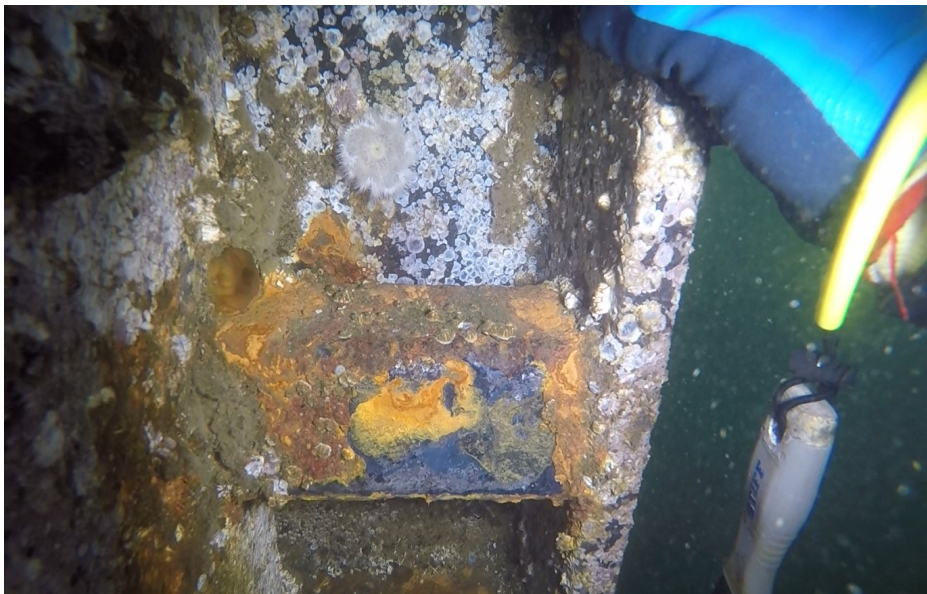
Seattle Diving Services, LLC		Photographic log	
Bremerton Underwater Inspection		Wave Attenuator Wall	<u>Location</u> South Seawall
Photo 15	Oct. 2018

<b>Client:</b> Port of Bremerton Bremerton, Wa.98337			
<b>Description:</b> View of typical corrosion on square tube bracing.

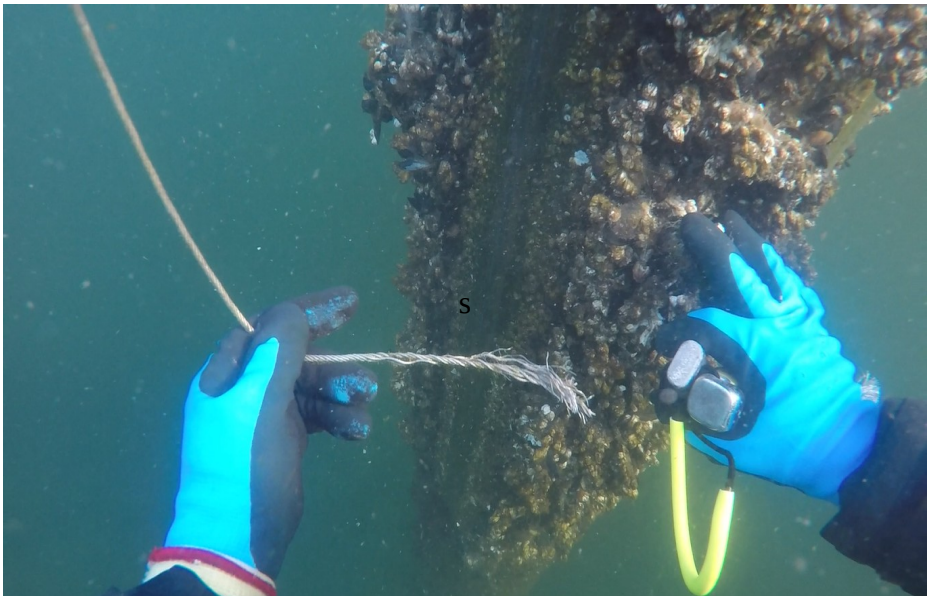
Seattle Diving Services, LLC		Photographic log	
Bremerton Underwater Inspection		Pilot Piles	<u>Location</u> Pile A-26
Photo 18	Oct. 2018

<b>Client:</b> Port of Bremerton Bremerton, Wa.98337			
<b>Description:</b> View of broken anode cable on Pilot Pile A-26.

Piling A-26 anode was found damaged & disconnected. This anode should be considered for repair and replacement as soon as possible. Pilings E-49 & E-46 did not have cathodic protection installed but moderate surface was rust discovered. Anode installation should be considered within the next year for pilings on E-dock.

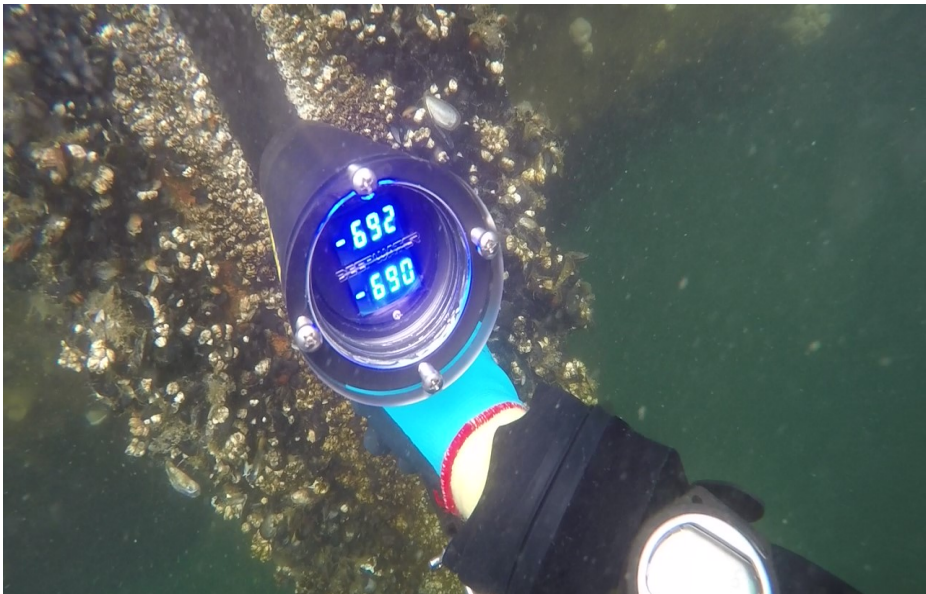
Seattle Diving Services, LLC		Photographic log	
Bremerton Underwater Inspection		Pilot Piles	<u>Location</u> Pile P-35
Photo 20	Oct. 2018

<b>Client:</b> Port of Bremerton Bremerton, Wa.98337			
<b>Description:</b> View of typical abrasion from pile guide on P-35. No damage.
