Underwater Inspection of Marine Facilities  
707 Sidney Pkwy, Port Orchard, WA 98366

Prepared by SDS Consultant  
November 2020

# Harper Pier Underwater Inspection

**Port Orchard Marina**  
707 Sidney Pkwy, Port Orchard, WA 98366

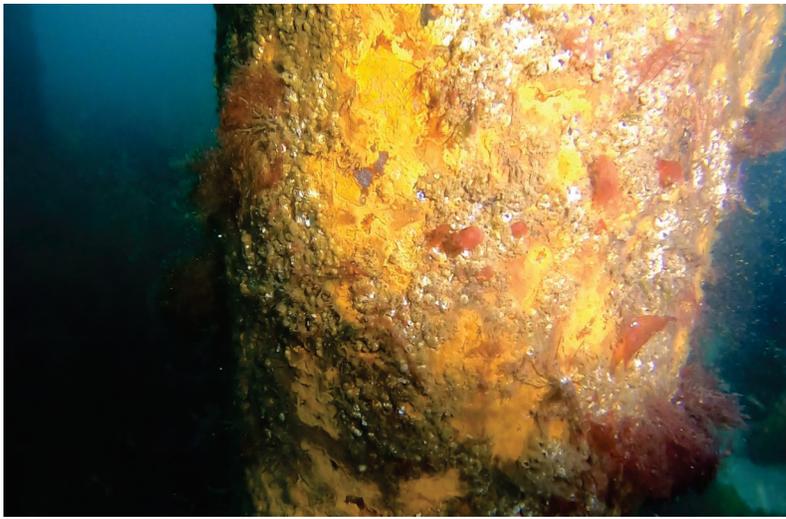
Seattle Diving Services, LLC		Photographic log	
Harper Pier		Pilot Piles	
		Photo 1	
<p><b>Client:</b> Port of Bremerton Bremerton, Wa.98337</p>

Cathodic protection should be considered for all pilings supporting the Harper pier that have a sub-tidal zone. The sub tidal zone on every piling inspected was subject to advanced corrosion & deterioration. An impressed current cathodic protection system could be used, but could also become very costly. Alternatively,

<p><b>Description:</b> Advanced corrosion in submerged zone of pilot pile</p>

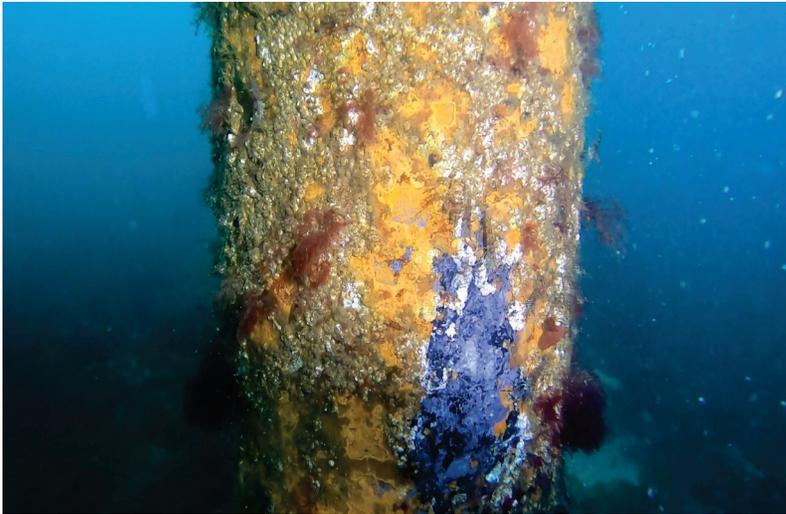
Seattle Diving Services, LLC		Photographic log	
Harper Pier		Pilot Piles	
		Photo 2	
<p><b>Client:</b> Port of Bremerton Bremerton, Wa.98337</p>

<p><b>Description:</b> Advanced corrosion in submerged zone of pilot pile</p>

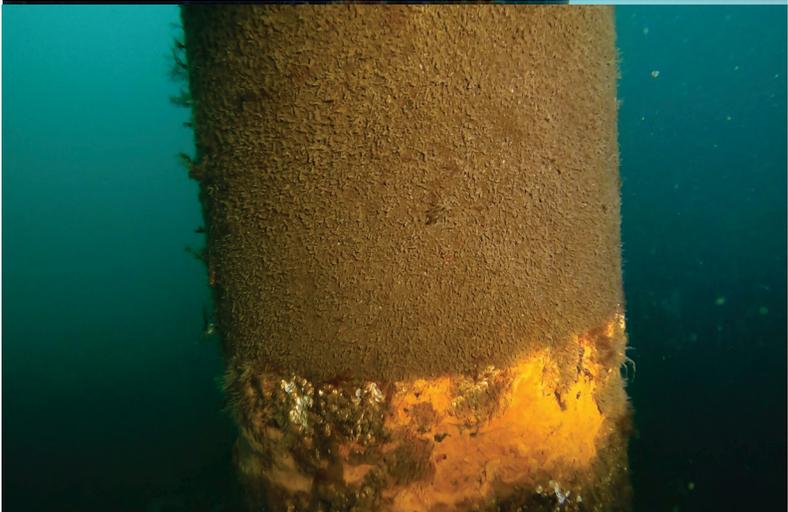
Seattle Diving Services, LLC		Photographic log
Bremerton Underwater Inspection	Pilot Piles	Photo 3
<b>Client:</b> Port of Bremerton Bremerton, Wa.98337

<b>Description:</b> Inter-tidal zone meets submerged zone of pile. Galvanizing intact

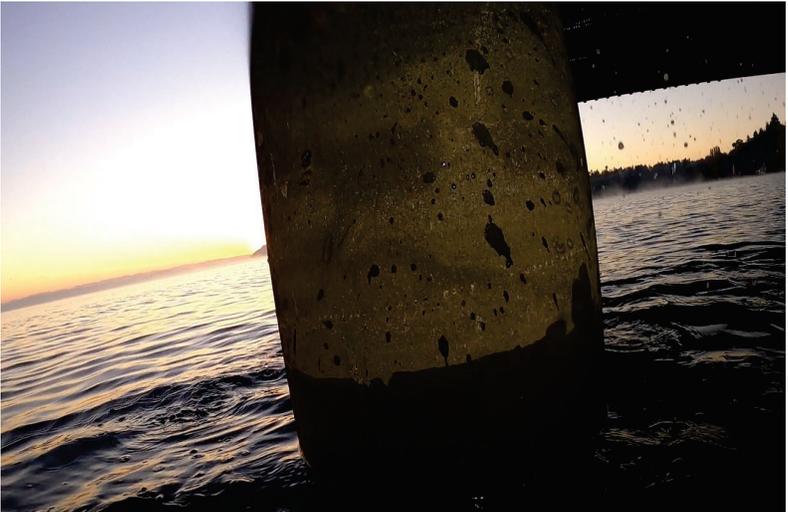
Seattle Diving Services, LLC		Photographic log
Harper Pier	Pilot Piles	Photo 4
<b>Client:</b> Port of Bremerton Bremerton, Wa.98337

<b>Description:</b> Splash/ high tide zone of pilot pile. Galvanizing intact.

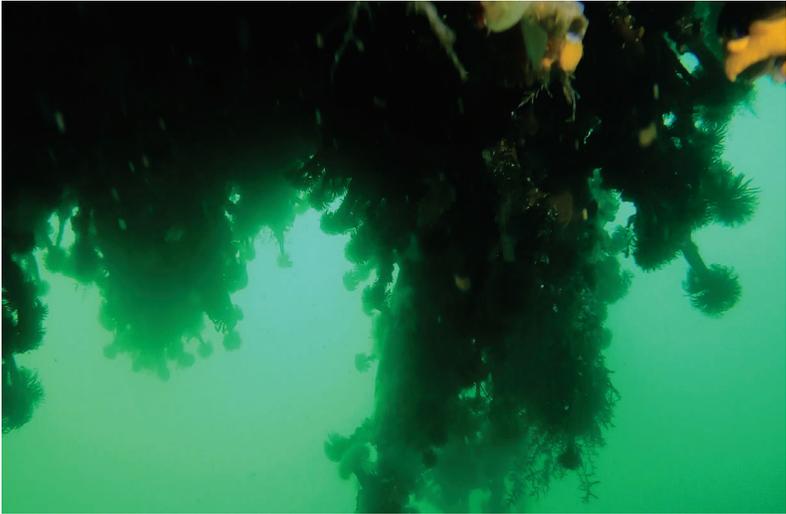
Seattle Diving Services, LLC		Photographic log	
Port Orchard Marina		Floating Breakwater	Photo 5

The floating breakwater was observed to be in general overall satisfactory condition. Heavy marine growth covered the majority of the breakwater's surface. However, no cracking, spalling, severe corrosion, major damage, or deterioration due to over stressing was detected during the inspection. Floating breakwater mooring lines were found to be in overall Fair condition with localized areas of moderate deterioration. Heavy marine growth covered the majority of the mooring lines. However, the growth was minimal enough to conduct an adequate level I inspection and determine anode & mooring line condition. (See Photos 5-6).

<b>Client:</b> Port of Bremerton Bremerton, Wa.98337			
<b>Description:</b> Typical marine growth conditions beneath the breakwater

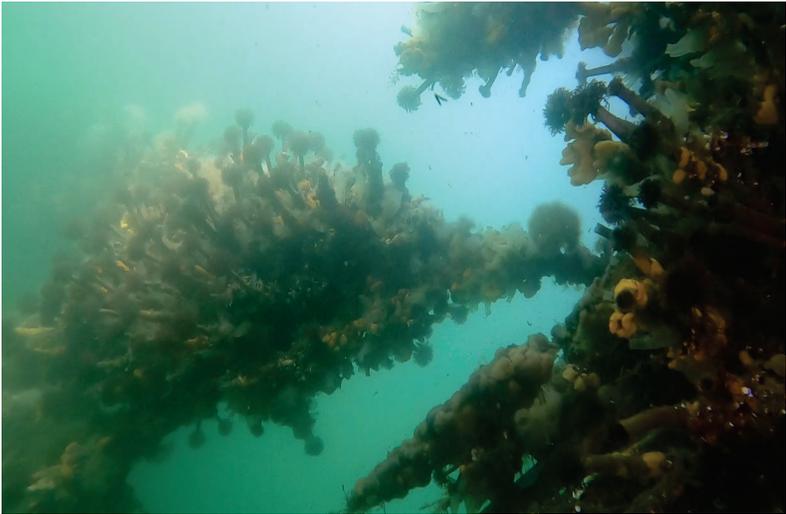
Seattle Diving Services, LLC		Photographic log	
Port Orchard Marina		Floating Breakwater	Photo 6

<b>Client:</b> Port of Bremerton Bremerton, Wa.98337			
<b>Description:</b> Typical marine growth conditions on mooring lines

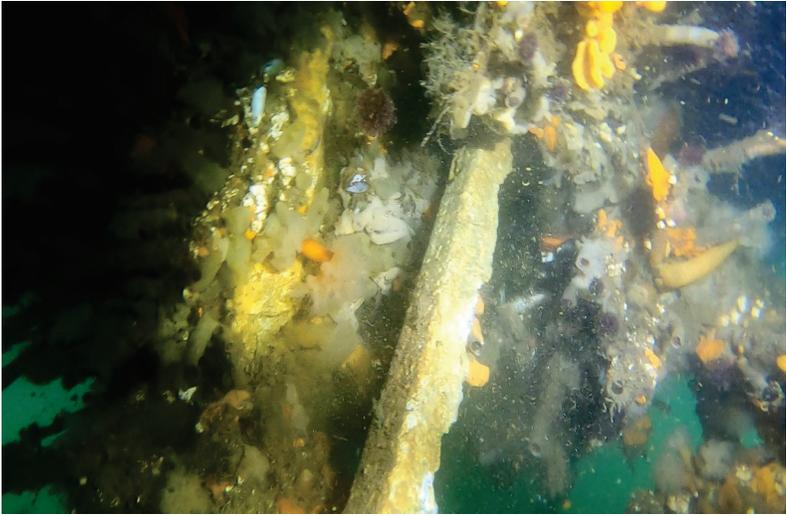
Seattle Diving Services, LLC		Photographic log
Port Orchard Marina	Floating Breakwater	Photo 7
<b>Client:</b> Port of Bremerton Bremerton, Wa.98337

Breakwater mooring lines were covered in heavy marine growth but was adequate enough for a level I visual & tactile inspection. The previous underwater inspection in 2018 showed remaining anode percentages identical to this year's underwater inspection. All anodes were zinc material and the surfaces had a yellowish tint. Upon physical examination (scraping and wiring brushing) of the anode surface, it exposed clean and active zinc material. This yellowish tint is a telltale sign that the anode material is not actively corroding. There are measures that can be taken to counter act this process, this is the reasoning for anode percentages being identical to the 2018 inspection. (Photos 7-8).

<b>Description:</b> Top chain anode with calcified outer layer

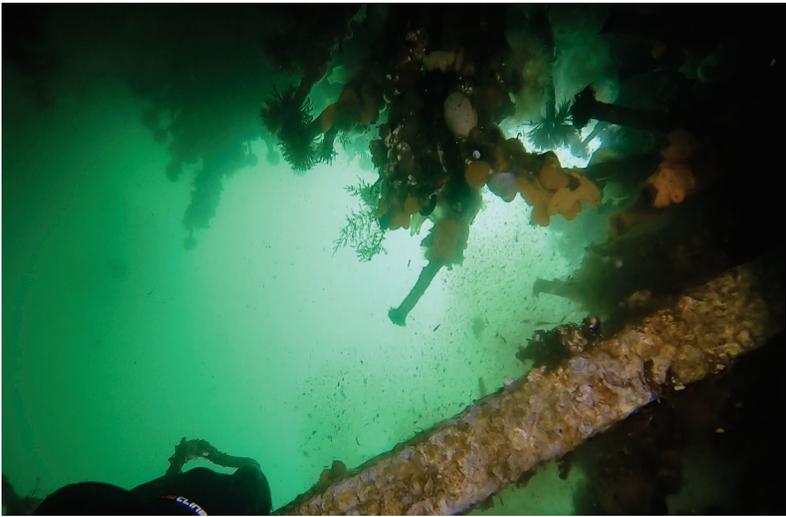
Seattle Diving Services, LLC		Photographic log
Port Orchard Marina	Floating Breakwater	Photo 8
<b>Client:</b> Port of Bremerton Bremerton, Wa.98337

<b>Description:</b> Top chain anode with calcified outer layer

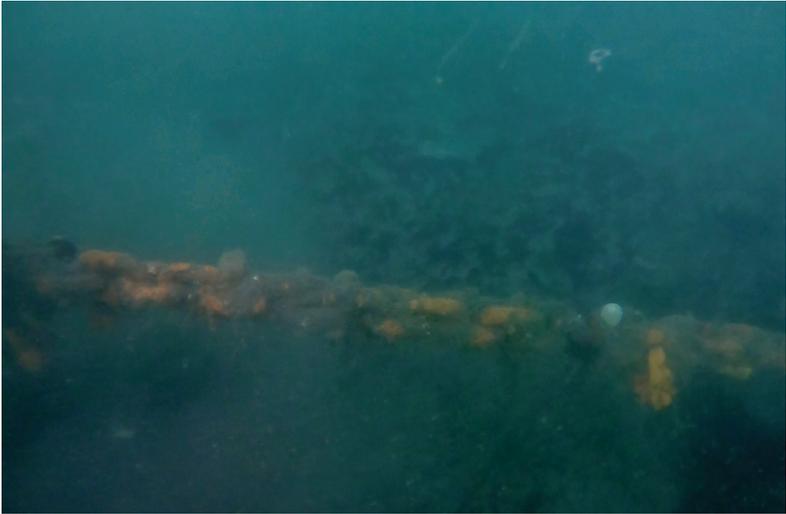
Seattle Diving Services, LLC		Photographic log	
Port Orchard Marina		Floating Breakwater	
		Photo 9	
<p><b>Client:</b> Port of Bremerton Bremerton, Wa.98337</p>

Mooring line numbers 11, 20, 54, 68, & 70 were all observed to have advanced corrosion such as surface rust on the bottom chain and connections. (See Photos 9-10).

<p><b>Description:</b> Advanced surface corrosion on bottom chain</p>

Mooring line numbers 11, 20, 54, 68, & 70 were all observed to have advanced corrosion on the bottom chain and connections. In-kind rehabilitation would involve one additional anode installed at the top of the bottom chain and include proper cleaning sufficient enough to ensure contact between the bottom chain and cathodic protection. These repairs need to be carried out with moderate urgency.

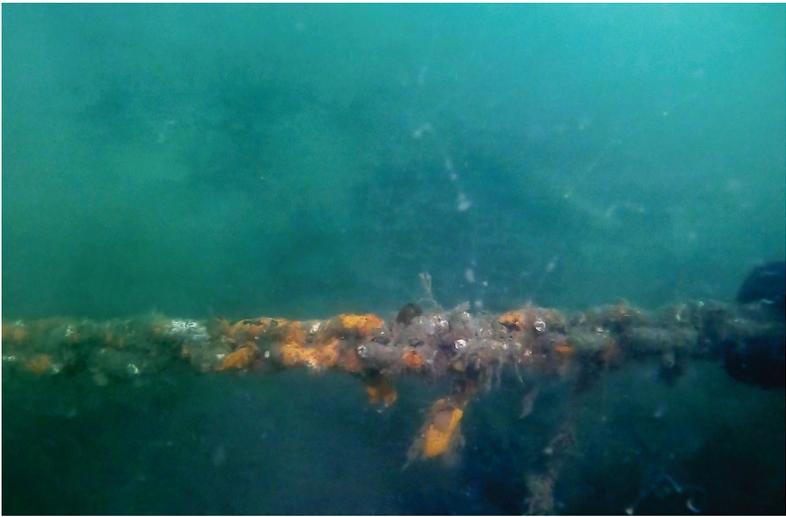
Seattle Diving Services, LLC		Photographic log	
Port Orchard Marina		Floating Breakwater	
		Photo 10	
<p><b>Client:</b> Port of Bremerton Bremerton, Wa.98337</p>

<p><b>Description:</b> Advanced surface corrosion on bottom chain</p>

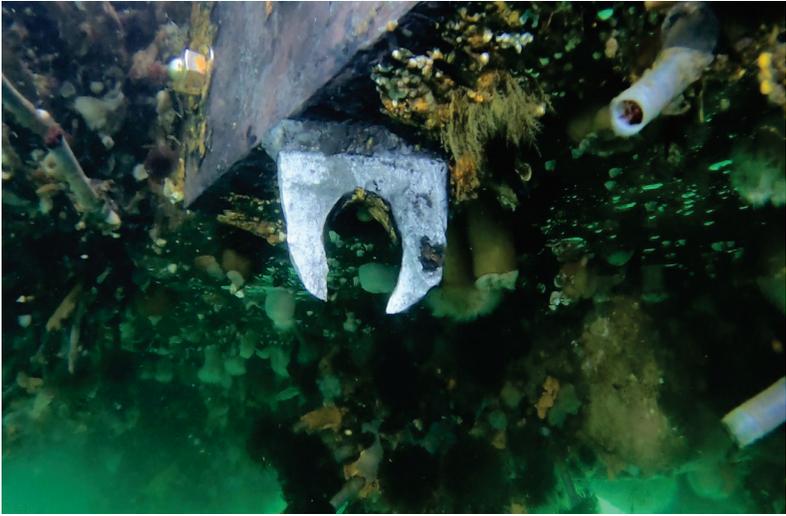
Seattle Diving Services, LLC		Photographic log
Port Orchard Marina	Bridal Chains	Photo 11

Thirteen bridle chain systems were listed for level II inspection. Fourteen bridle chain systems were found, three of which were disconnected. Mounting brackets for bridle chain 35 was subject to advanced deterioration and pad eye bracket failure. (Photo 11) The originating cause behind the failure is suspected to be ordinary wear from the 1" shackle connecting the 1/2" long-link bridle chain to the bracket. Under the influence of waves, currents, and galvanic corrosion these two components had worn and failed. Bridle bracket 11 had similar deterioration but

<b>Client:</b>	Port of Bremerton Bremerton, Wa.98337	
<b>Description:</b>	Bridal bracket 35 pad eye failure

The bridle chain 35 has a bracket that has deteriorated to a point of failure. This bracket and associated bridle chain should be considered for in-kind replacement as soon as possible. Bridle bracket 11 is subject to advanced deterioration. If the intended life expectancy of the breakwater is more than two years, this bracket should also be replaced. If the intended life expectancy is less than two years, the existing bracket will be sufficient to continue its intended purpose. Bridle chain 11 will also need to be replaced regardless of bracket replacement. New cathodic protection will need to be installed on the bridle chain only.

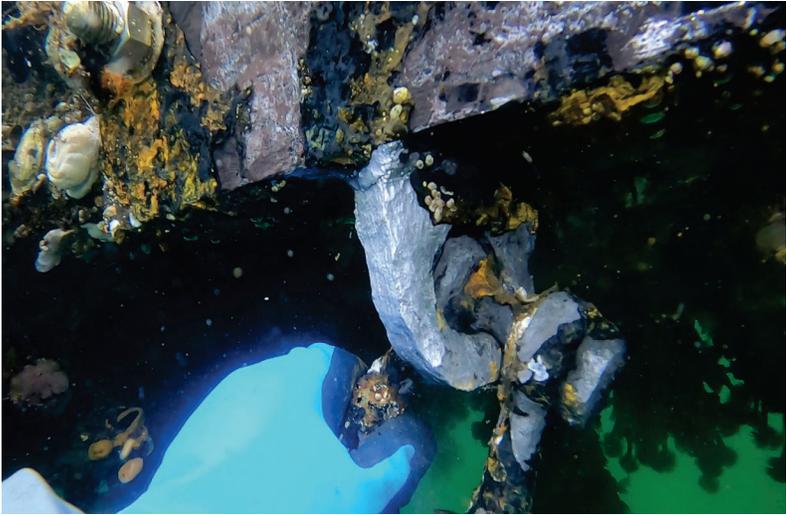
Seattle Diving Services, LLC		Photographic log
Port Orchard Marina	Bridal Chains	Photo 12

failed at the top chain link connecting the bridle chain to the pad eye on the bridle bracket. (Photo 12 & 13) The lower connection of these bridle chains were still

<b>Client:</b>	Port of Bremerton Bremerton, Wa.98337	
<b>Description:</b>	Bridal bracket 9 & chain failure

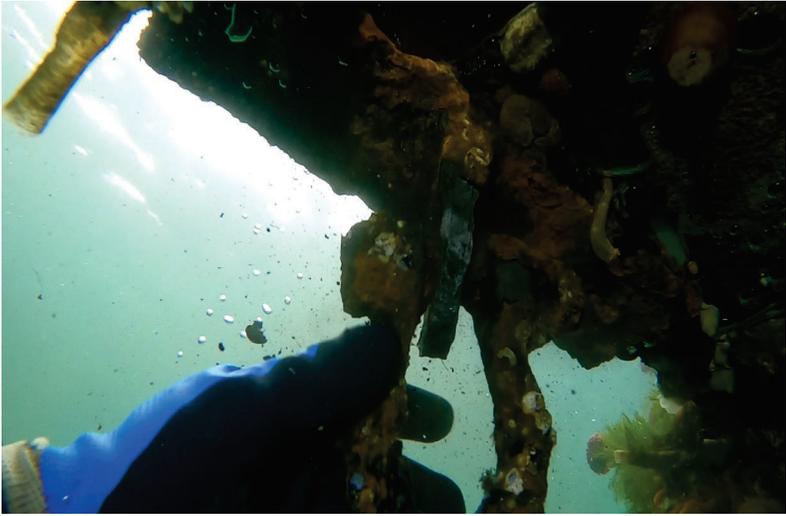
Seattle Diving Services, LLC		Photographic log
Port Orchard Marina	Bridal Chains	Photo 13

<b>Client:</b>		
Port of Bremerton Bremerton, Wa.98337		
<b>Description:</b>		
Bridal bracket 9 & chain failure

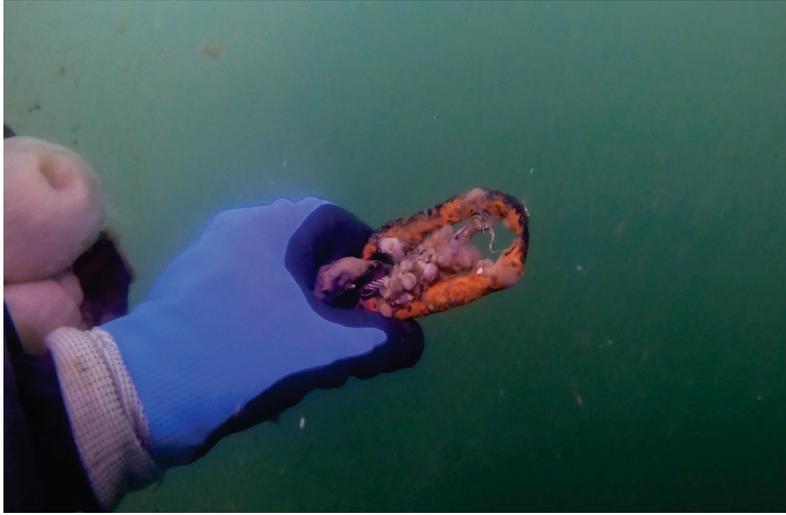
Seattle Diving Services, LLC		Photographic log
Port Orchard Marina	Bridal Chains	Photo 14

connected to the mooring lines and were found to have advanced deterioration. (Photo 14) Minor issue findings include missing cotter pins and seizing wire for lower bridle connections of bridle numbers 42 & 59.

<b>Client:</b>		
Port of Bremerton Bremerton, Wa.98337		
<b>Description:</b>		
Advanced corrosion at bottom of bridal chain 9

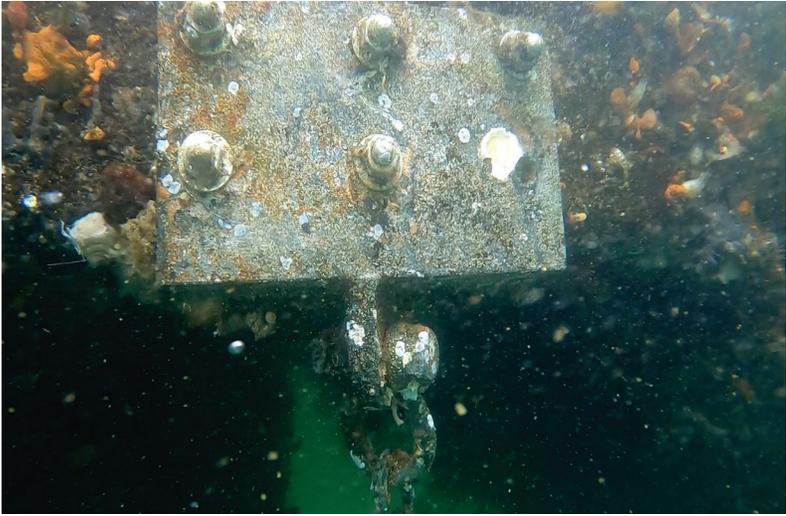
Seattle Diving Services, LLC		Photographic log
Port Orchard Marina	Bridal Chains	Photo 15
<b>Client:</b> Port of Bremerton Bremerton, Wa.98337

<b>Description:</b> Typical bridal bracket post cleaning

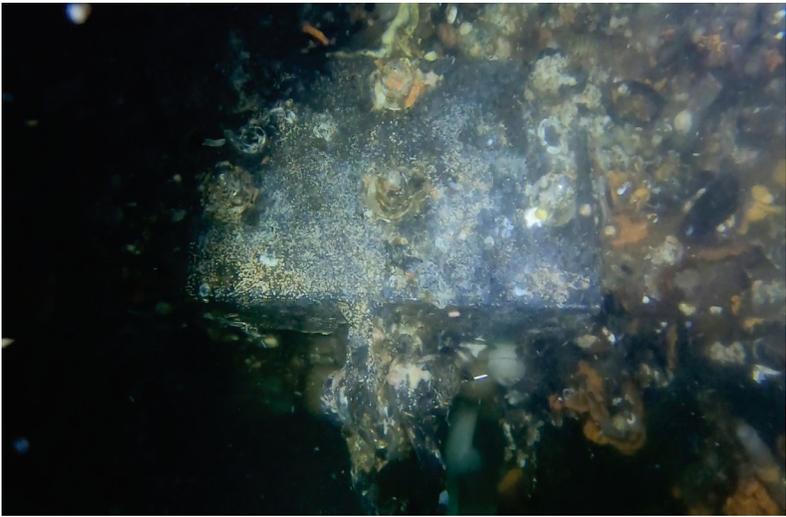
Seattle Diving Services, LLC		Photographic log
Port Orchard Marina	Bridal Chains	Photo 16
<b>Client:</b> Port of Bremerton Bremerton, Wa.98337

<b>Description:</b> Typical bridal bracket condition

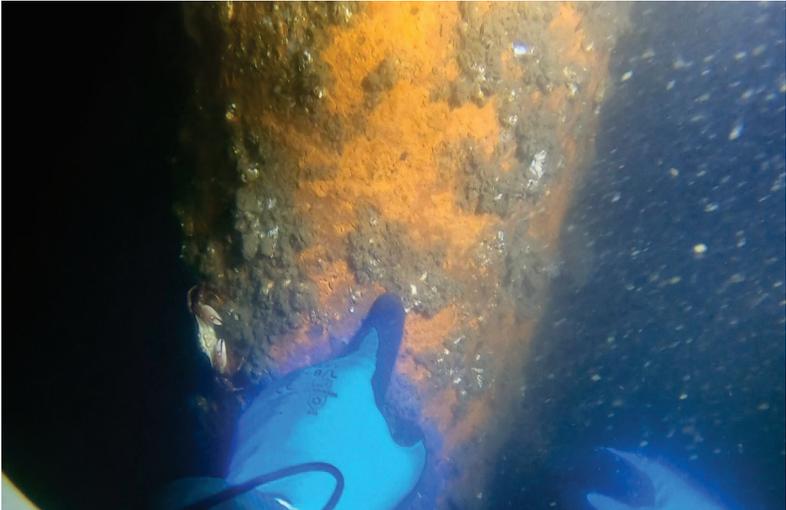
<b>Seattle Diving Services, LLC</b>		<b>Photographic log</b>	
Port Orchard Marina		Pilot Piles	
		Photo 17	
<p><b>Client:</b> Port of Bremerton Bremerton, Wa.98337</p> <p><b>Description:</b> Submerged zone of B-6 with 100% surface rust coverage</p>

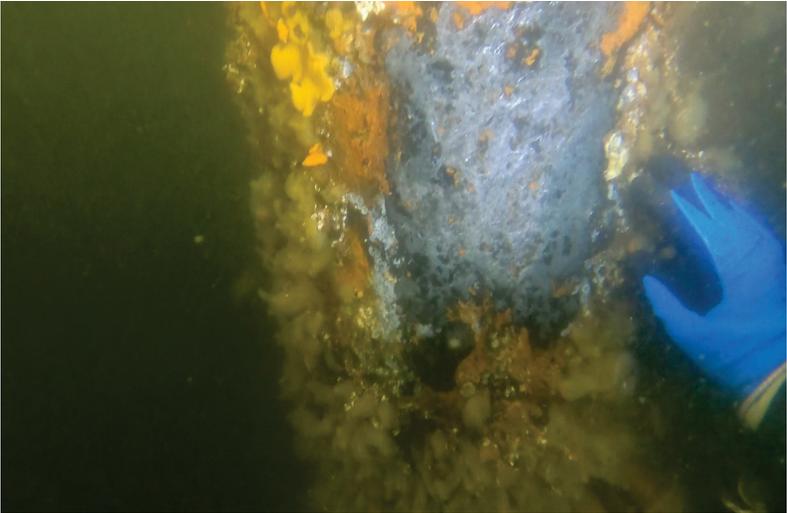
Seattle Diving Services, LLC		Photographic log
Port Orchard Marina	Pilot Piles	Photo 18
<b>Client:</b> Port of Bremerton Bremerton, Wa.98337

<b>Description:</b> Mid-water of pile B-1 post cleaning for U/T & C/P readings

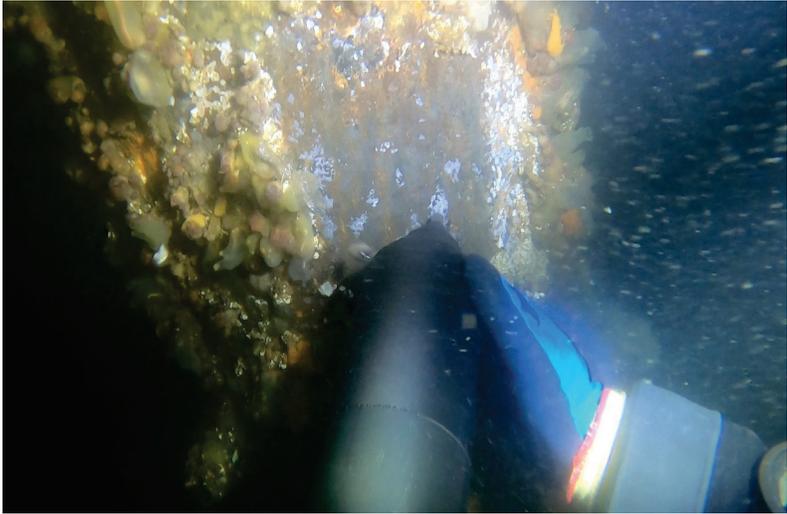
Seattle Diving Services, LLC		Photographic log
Port Orchard Marina	Pilot Piles	Photo 19
<b>Client:</b> Port of Bremerton Bremerton, Wa.98337

<b>Description:</b> Inter-tidal zone of pile C-17, typical conditions

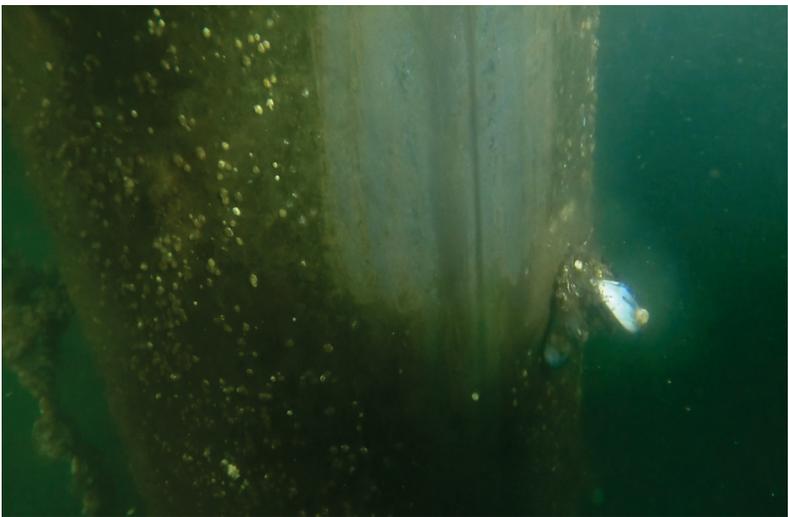
Seattle Diving Services, LLC		Photographic log
Port Orchard Marina	Pilot Piles	Photo 20
<b>Client:</b> Port of Bremerton Bremerton, Wa.98337

<b>Description:</b> High tide zone of pile D-44, typical surface conditions

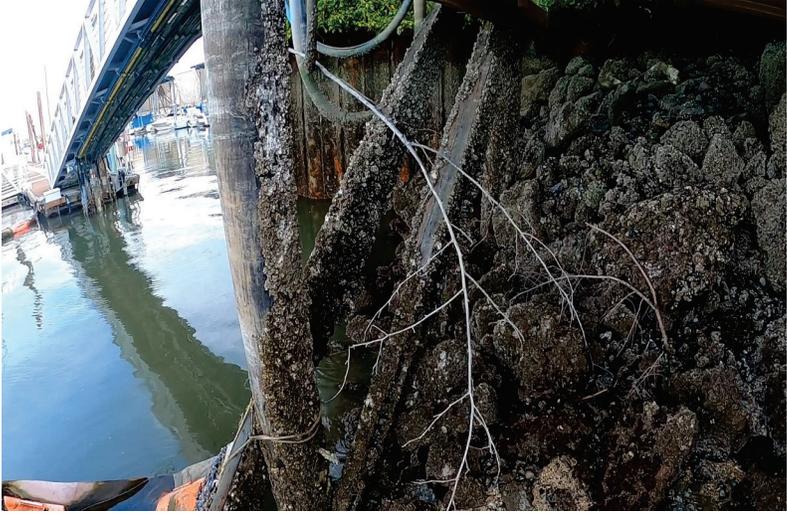
<b>Seattle Diving Services, LLC</b>		<b>Photographic log</b>	
Port Orchard Marina		Shoreline Building & Approach Docks	
		Photo 21	
<p><b>Client:</b> Port of Bremerton Bremerton, Wa.98337</p> <p><b>Description:</b> Approach dock A 4'x12' cross supports with moderate marine borer action towards bottom</p>

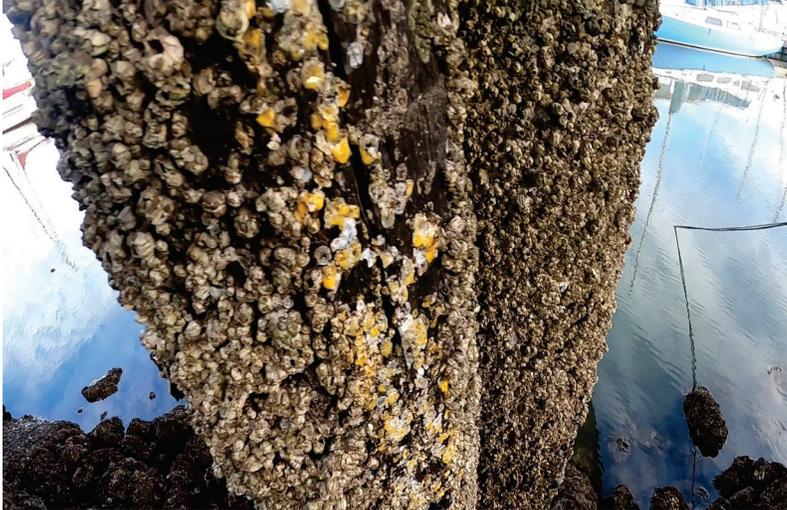
<b>Seattle Diving Services, LLC</b>		<b>Photographic log</b>	
Port Orchard Marina		Shoreline Building & Approach Docks	
		Photo 22	
<p><b>Client:</b> Port of Bremerton Bremerton, Wa.98337</p> <p><b>Description:</b> Support pile under B Approach dock with Moderate cracking</p>

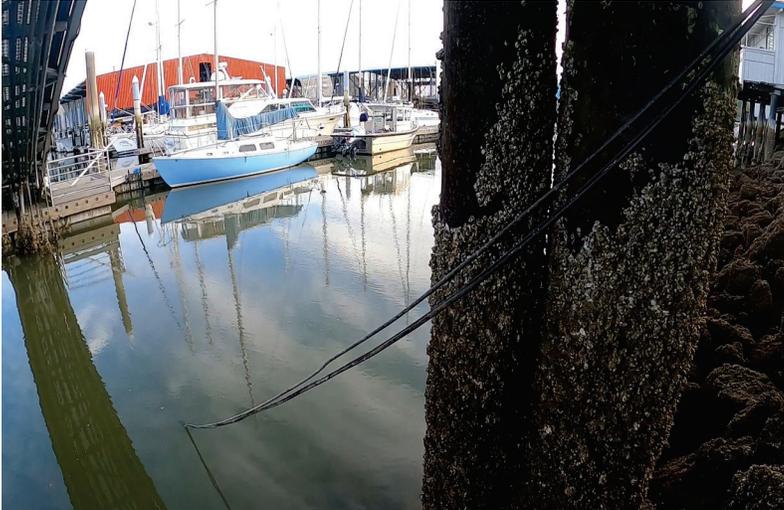
Seattle Diving Services, LLC		Photographic log
Port Orchard Marina	Shoreline Building & Approach Docks	Photo 23
<b>Client:</b> Port of Bremerton Bremerton, Wa.98337

<b>Description:</b> Communications or similar cable hanging unsupported below B approach dock

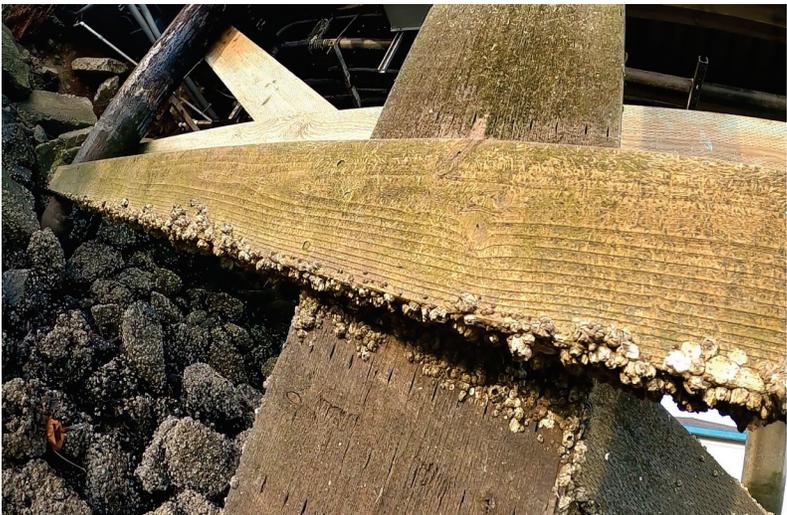
Seattle Diving Services, LLC		Photographic log
Port Orchard Marina	Shoreline Building & Approach Docks	Photo 24
<b>Client:</b> Port of Bremerton Bremerton, Wa.98337

<b>Description:</b> Untreated support member below G approach dock

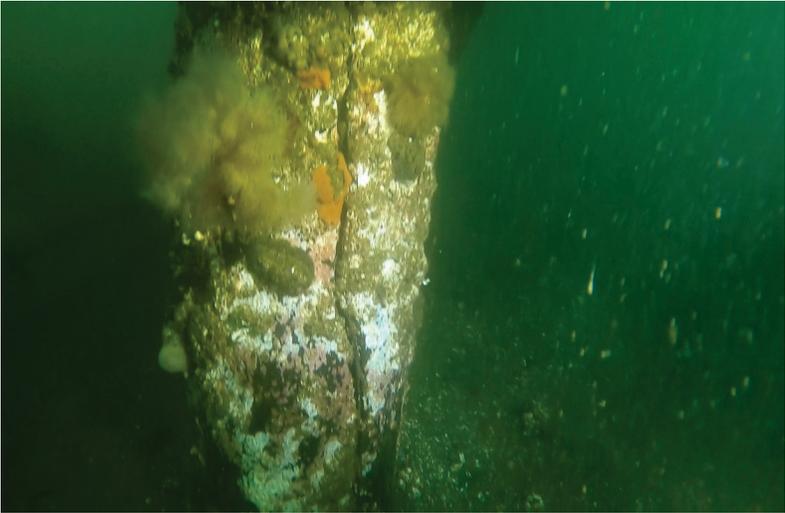
Seattle Diving Services, LLC		Photographic log
Port Orchard Marina	Shoreline Building & Approach Docks	Photo 25
<b>Client:</b> Port of Bremerton Bremerton, Wa.98337

<b>Description:</b> NE support piling for G approach dock. Cracking beginning at mudline

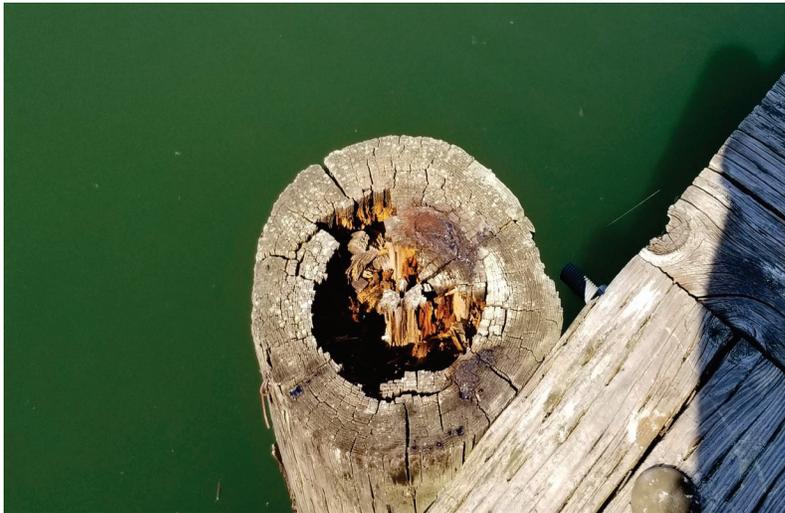
Seattle Diving Services, LLC		Photographic log
Port Orchard Marina	Shoreline Building & Approach Docks	Photo 26
<b>Client:</b> Port of Bremerton Bremerton, Wa.98337

<b>Description:</b> NW batter support Pile, G approach dock 50% material loss on pile cap

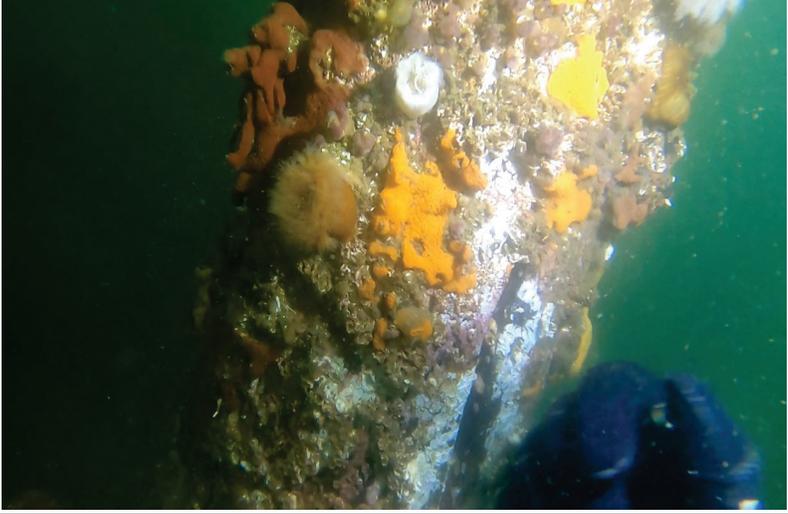
Seattle Diving Services, LLC		Photographic log
Port Orchard Marina	Shoreline Building & Approach Docks	Photo 27
<b>Client:</b> Port of Bremerton Bremerton, Wa.98337

<b>Description:</b> G approach dock western pile, second from north. Cracking & borer damage

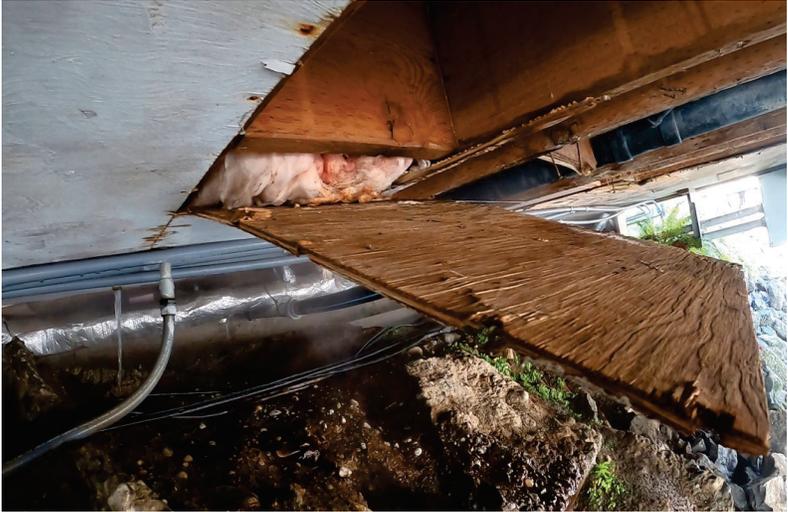
Seattle Diving Services, LLC		Photographic log
Port Orchard Marina	Shoreline Building & Approach Docks	Photo 28
<b>Client:</b> Port of Bremerton Bremerton, Wa.98337

<b>Description:</b> Loose board and running hot water flowing from bathroom building

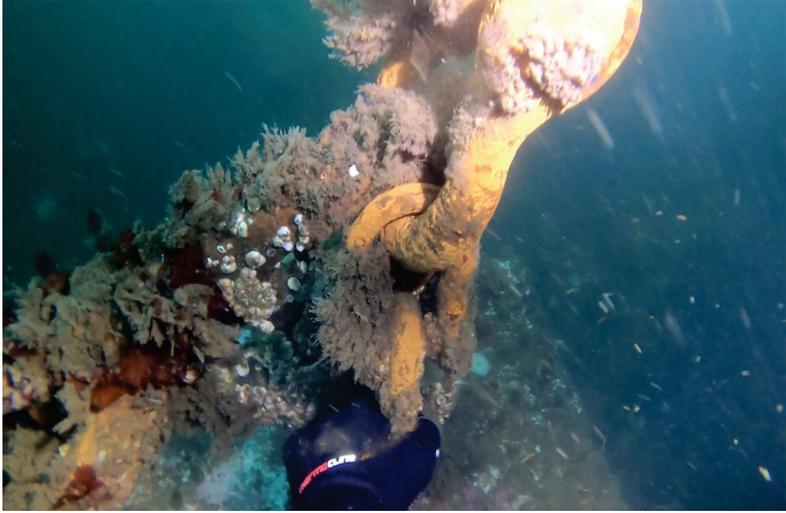
Seattle Diving Services, LLC		Photographic log
Port of Bremerton	USS Tuner Joy	Photo 29

<b>Client:</b> Port of Bremerton Bremerton, Wa.98337		
<b>Description:</b> Advanced corrosion & deterioration on upper section of Mooring system

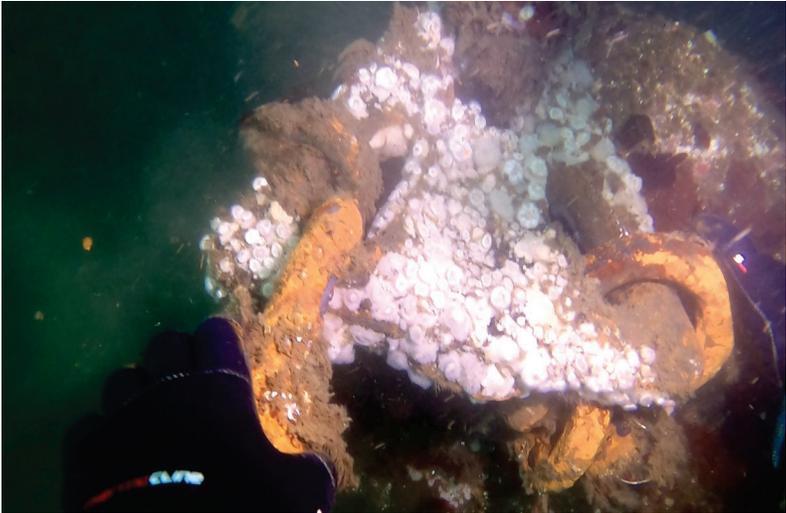
Seattle Diving Services, LLC		Photographic log
Port of Bremerton	USS Tuner Joy	Photo 30

<b>Client:</b> Port of Bremerton Bremerton, Wa.98337		
<b>Description:</b> Advanced corrosion at bow chain, float, & clump weight connection point

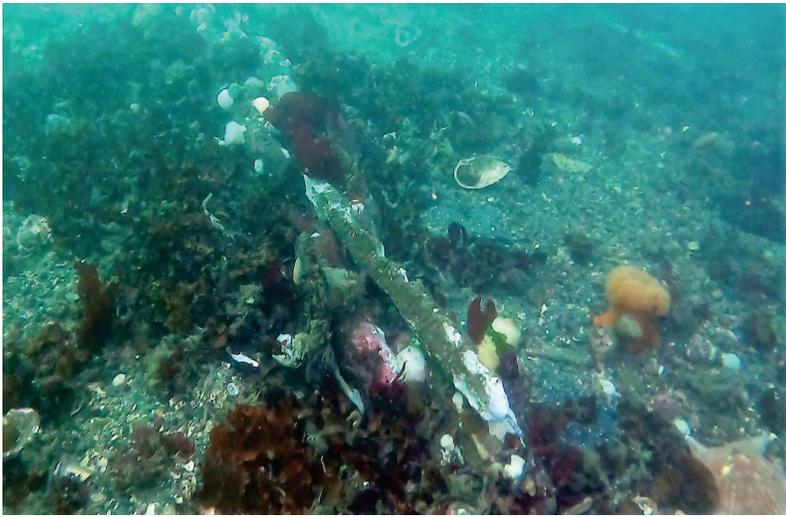
Seattle Diving Services, LLC		Photographic log
Port of Bremerton	USS Tuner Joy	Photo 31
<b>Client:</b> Port of Bremerton Bremerton, Wa.98337

<b>Description:</b> Typical anode & heavy chain condition

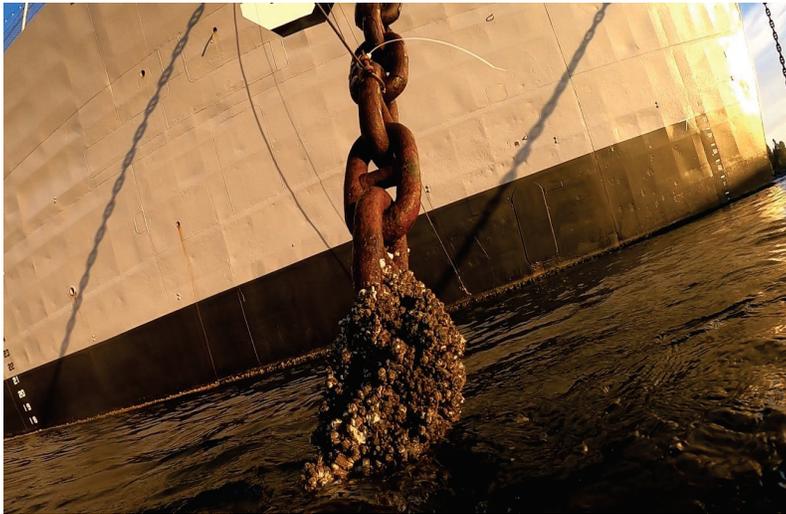
Seattle Diving Services, LLC		Photographic log
Port of Bremerton	USS Tuner Joy	Photo 32
<b>Client:</b> Port of Bremerton Bremerton, Wa.98337

<b>Description:</b> Typical bow chain condition at splash zone, light corrosion

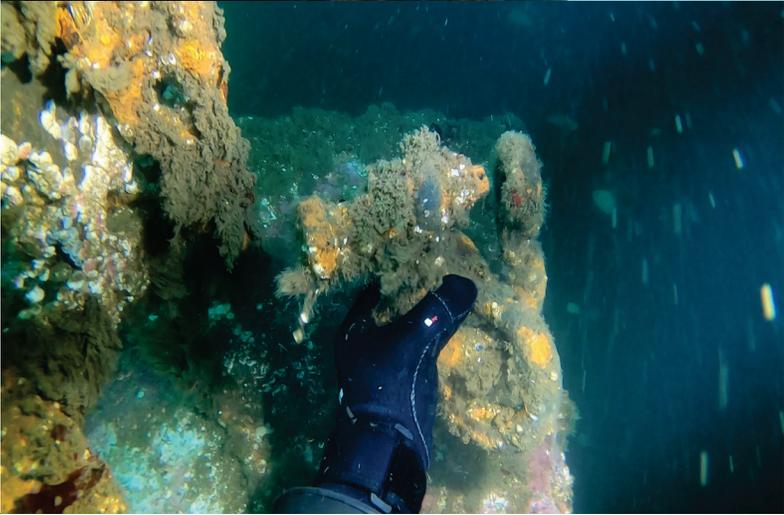
Seattle Diving Services, LLC		Photographic log
Port of Bremerton	USS Tuner Joy	Photo 33
<b>Client:</b> Port of Bremerton Bremerton, Wa.98337

<b>Description:</b> Failed bolt-type shackles found resting on clump weight

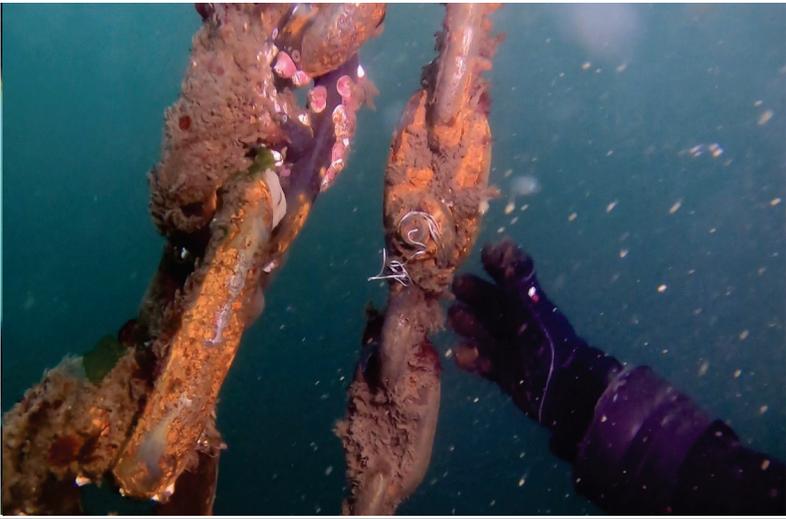
Seattle Diving Services, LLC		Photographic log
Port of Bremerton	USS Tuner Joy	Photo 34
<b>Client:</b> Port of Bremerton Bremerton, Wa.98337

<b>Description:</b> Float A1 bolt type shackle seizing wire coming undone

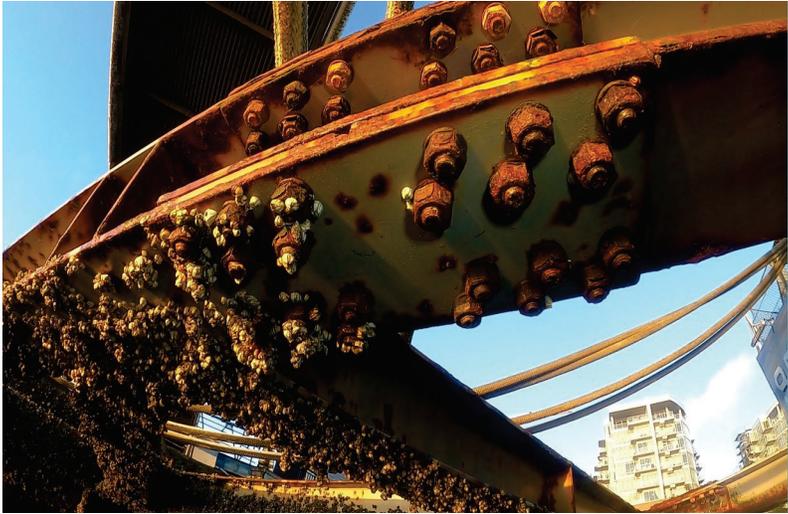
Seattle Diving Services, LLC		Photographic log	
Port of Bremerton		USS Tuner Joy	Photo 35
<b>Client:</b> Port of Bremerton Bremerton, Wa.98337

<b>Description:</b> Advanced corrosion on rear bridle connection

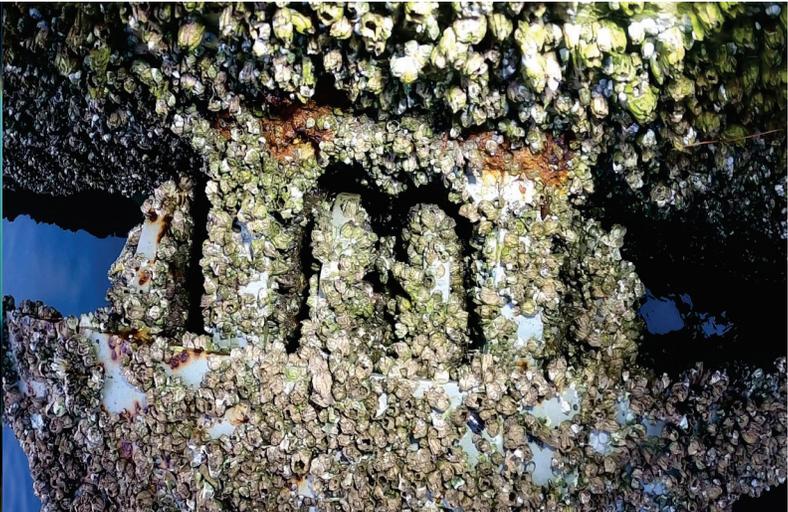
Seattle Diving Services, LLC		Photographic log	
Port of Bremerton		Pilot Piles	Photo 36
<b>Client:</b> Port of Bremerton Bremerton, Wa.98337

<b>Description:</b> Typical marine growth & corrosion condition on rear bridle pivot brackets

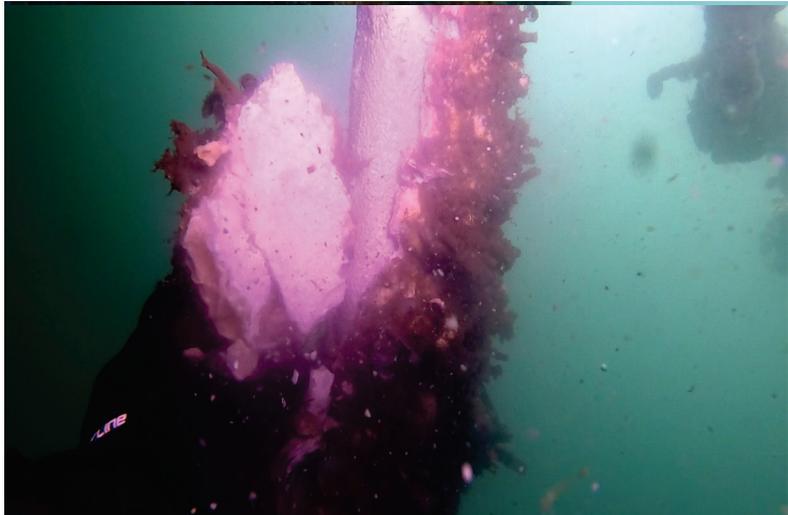
Seattle Diving Services, LLC		Photographic log
Port of Bremerton	Floating Wave Attenuator	Photo 37
<b>Client:</b> Port of Bremerton Bremerton, Wa.98337

<b>Description:</b> Removing anode outer calcification & marine growth layer exposing active metal

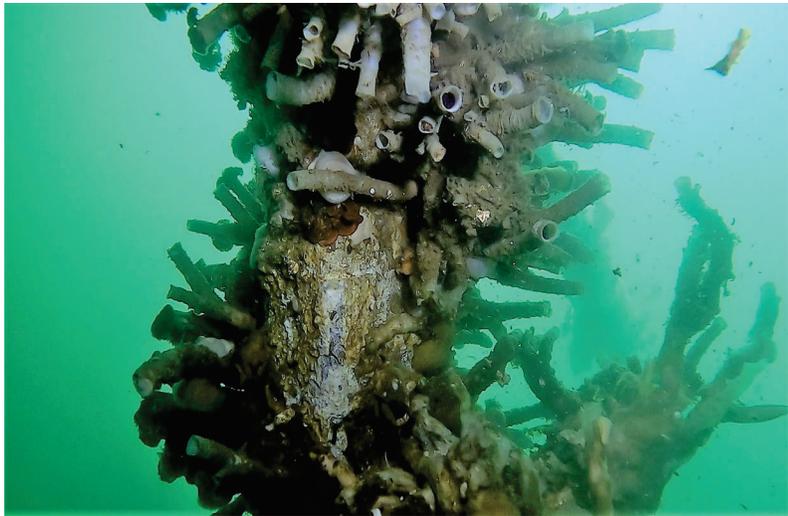
Seattle Diving Services, LLC		Photographic log
Port of Bremerton	Floating Wave Attenuator	Photo 38
<b>Client:</b> Port of Bremerton Bremerton, Wa.98337

<b>Description:</b> Typical anode condition, completely encased in heavy marine growth preventing anode depletion

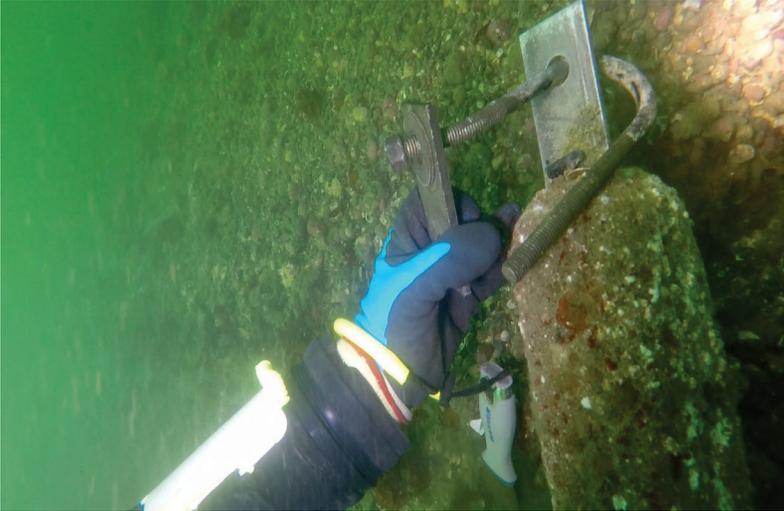
<b>Description:</b> Anode hardware failure disconnected & laying on seabed

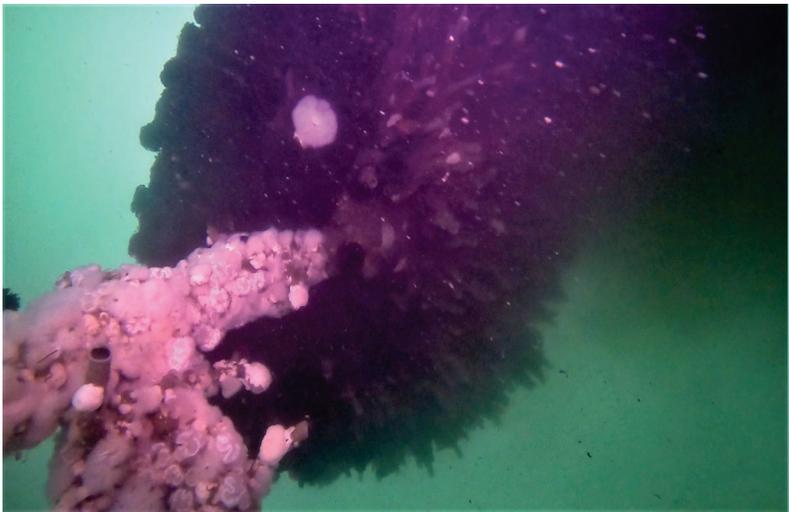
<b>Description:</b> Typical marine growth condition at top chain & cable connection & anode location. Tube worm colony 8' in diameter.

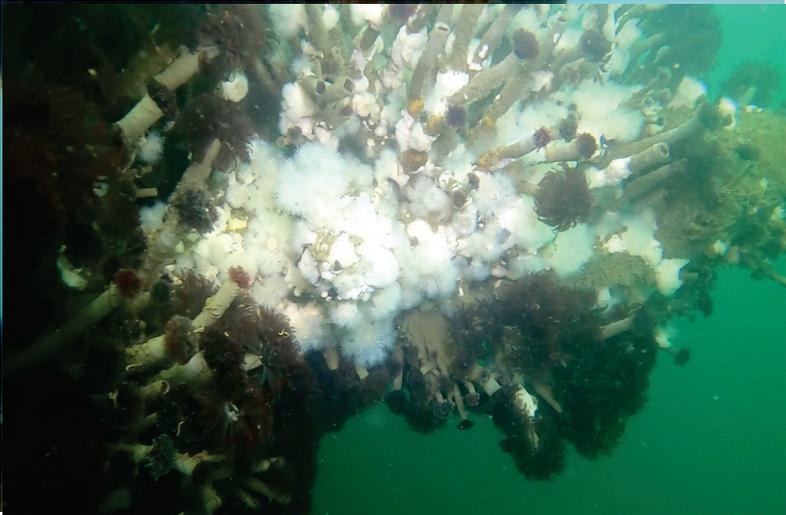
<b>Description:</b> Typical chain to cable Connection point & anode location encased in heavy marine growth

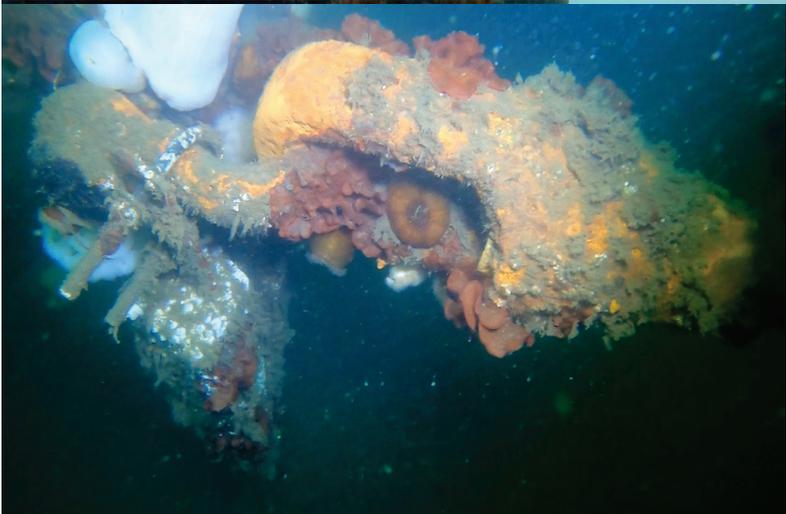
<b>Description:</b> Advanced surface corrosion at bottom cable to chain section of mooring line 19

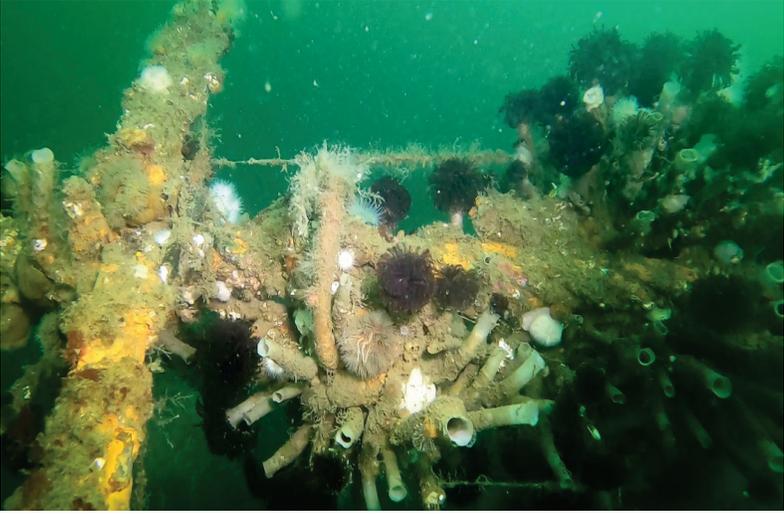
<b>Description:</b> Advanced surface corrosion at mid cable section of mooring line 19

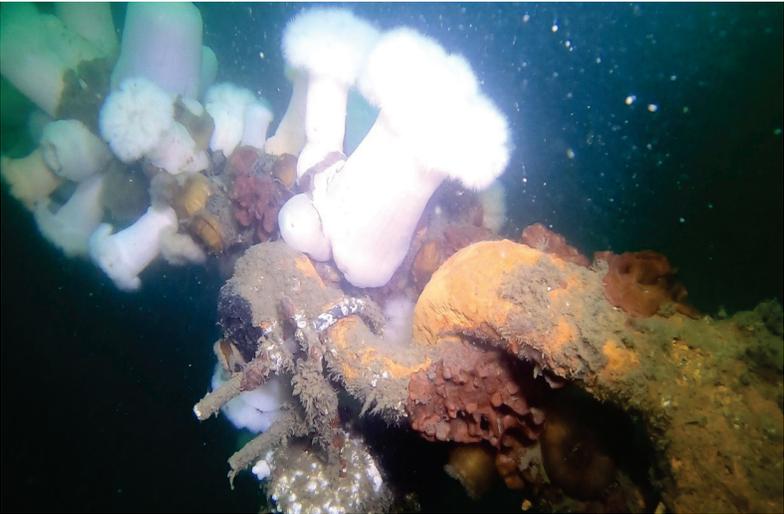
<b>Description:</b> Moderate surface corrosion at bottom chain section of mooring line 37

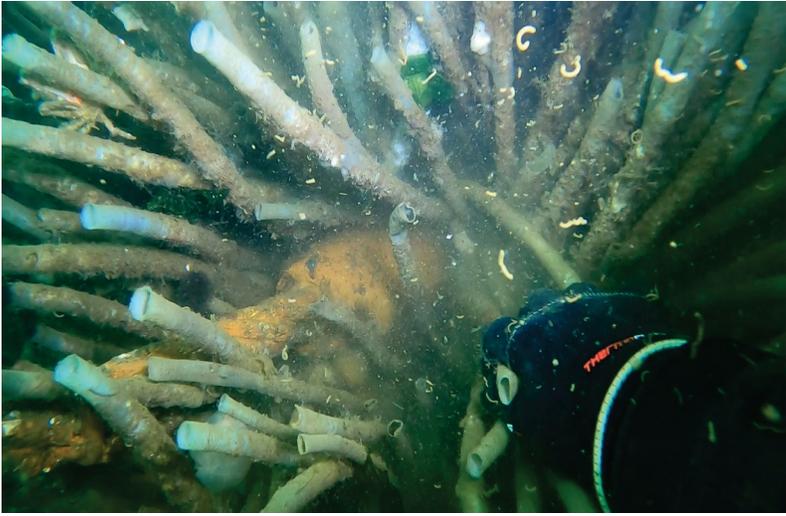
<b>Description:</b> Moderate surface corrosion at top cable socket on mooring line 31N

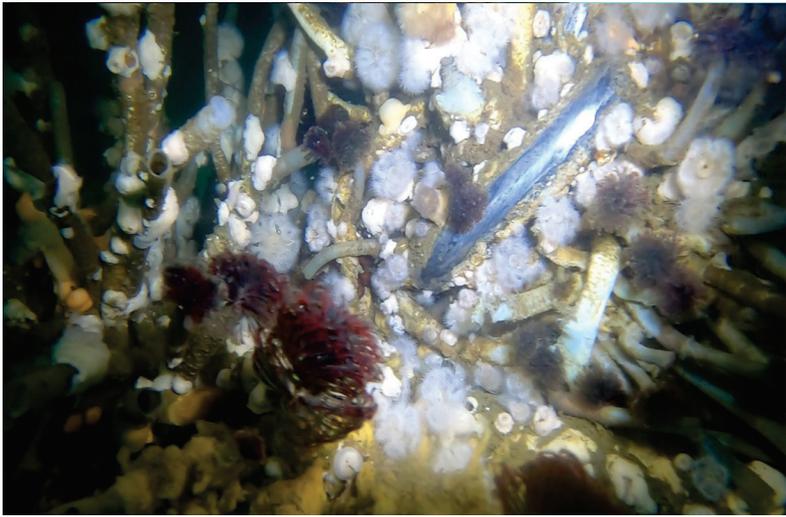
<b>Description:</b> Typical top chain section with minor abrasion from opposing mooring line

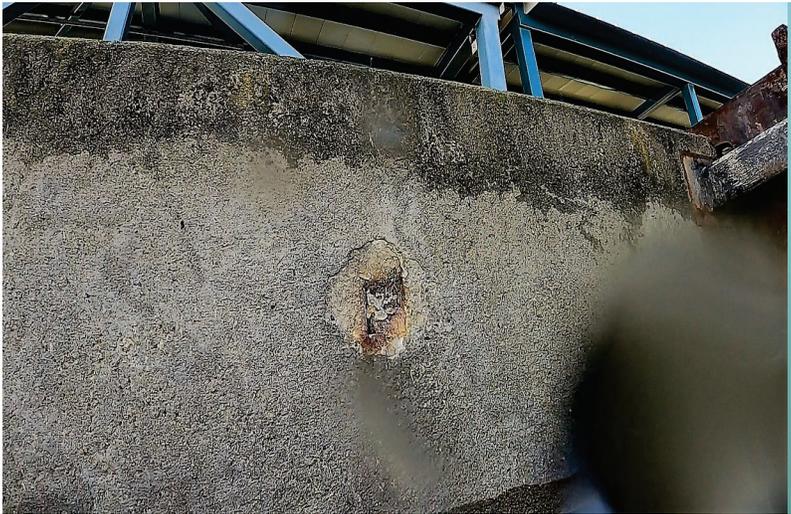
<b>Description:</b> Typical concrete patch in splash zone with minor rust coming through
