Underwater Inspection of Marine Facilities  
707 Sidney Pkwy, Port Orchard, WA 98366

Prepared by SDS Consultant  
November 2020

# Harper Pier Underwater Inspection

**Port Orchard Marina**  
707 Sidney Pkwy, Port Orchard, WA 98366

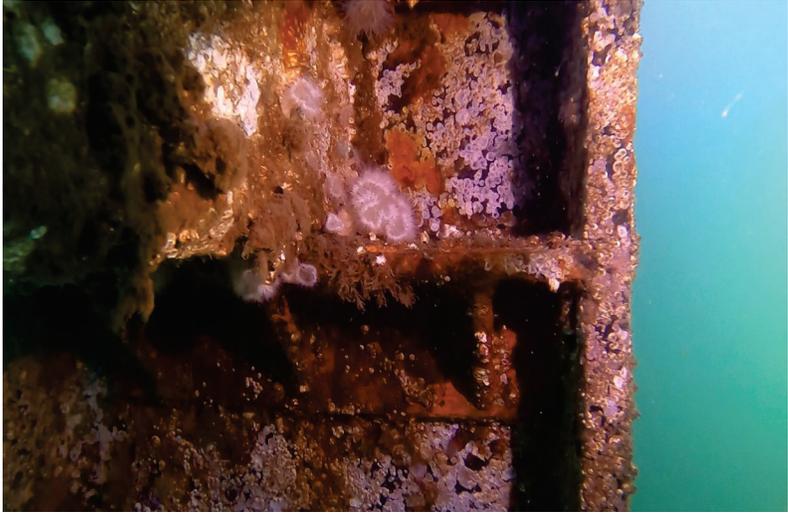
Seattle Diving Services, LLC		Photographic log	
Port of Bremerton		South Side Wave Attenuator Wall	Photo 49
<p><b>Client:</b> Port of Bremerton Bremerton, Wa.98337</p> <p><b>Description:</b> Typical H-pile &amp; welded bracket corrosion in inter-tidal zone</p>

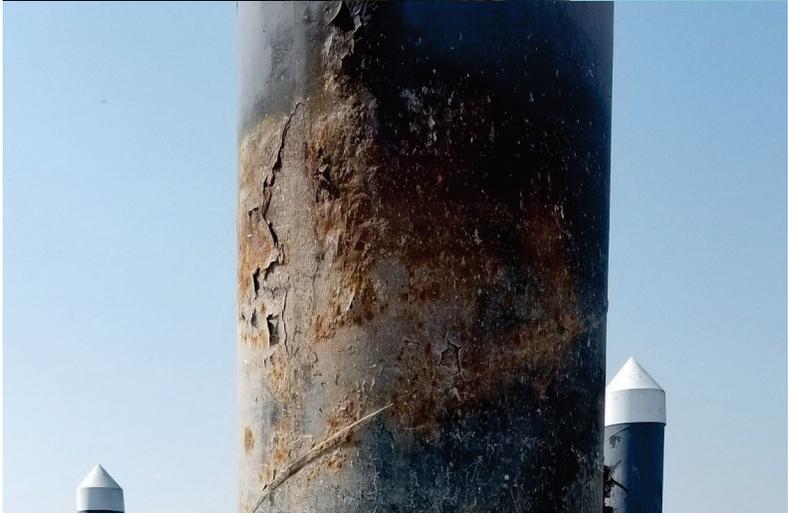
<b>Description:</b> Typical coating delamination & surface corrosion at splash zone

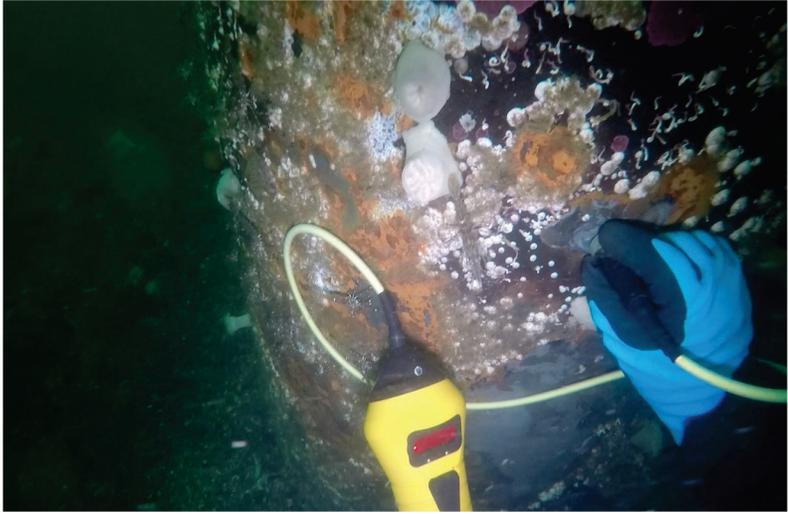
<b>Description:</b> Moderate surface corrosion & deterioration on pilot pile E-49

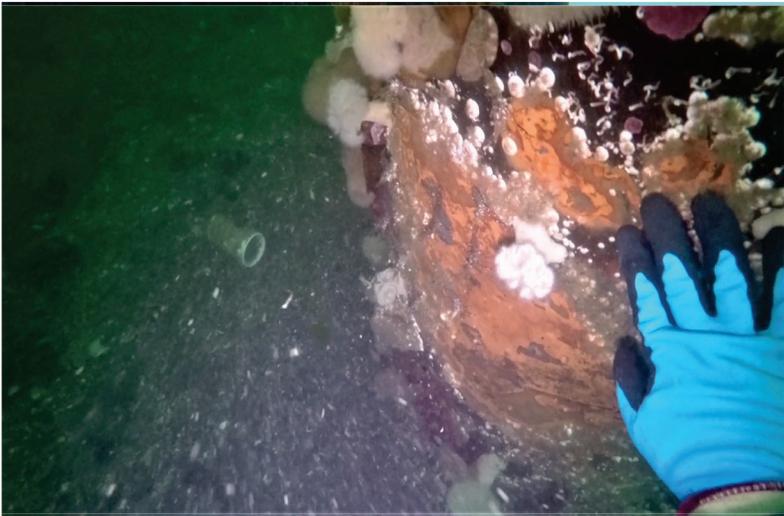
<b>Description:</b> Moderate surface corrosion & deterioration on pilot pile E-26

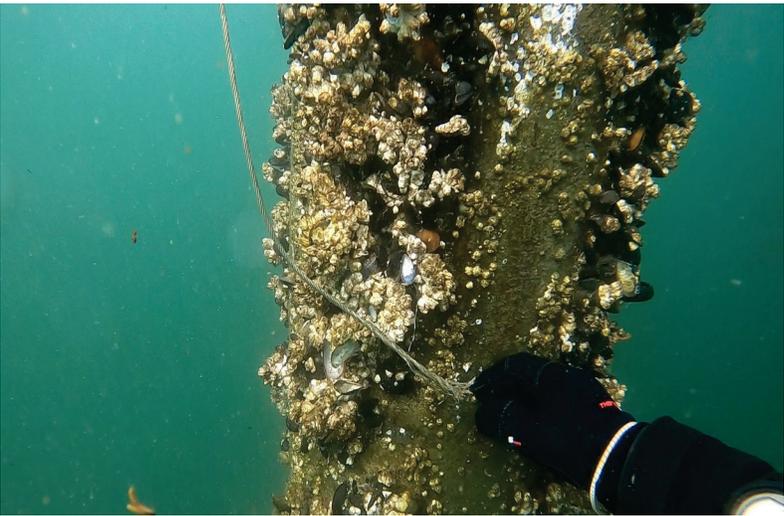
<b>Description:</b> Broken anode cable on pilot pile A-26
