Marine Facilities Study – Port Orchard Marina for Port of Bremerton

Kitsap County, WA

June 2016

MARINE FACILITIES STUDY

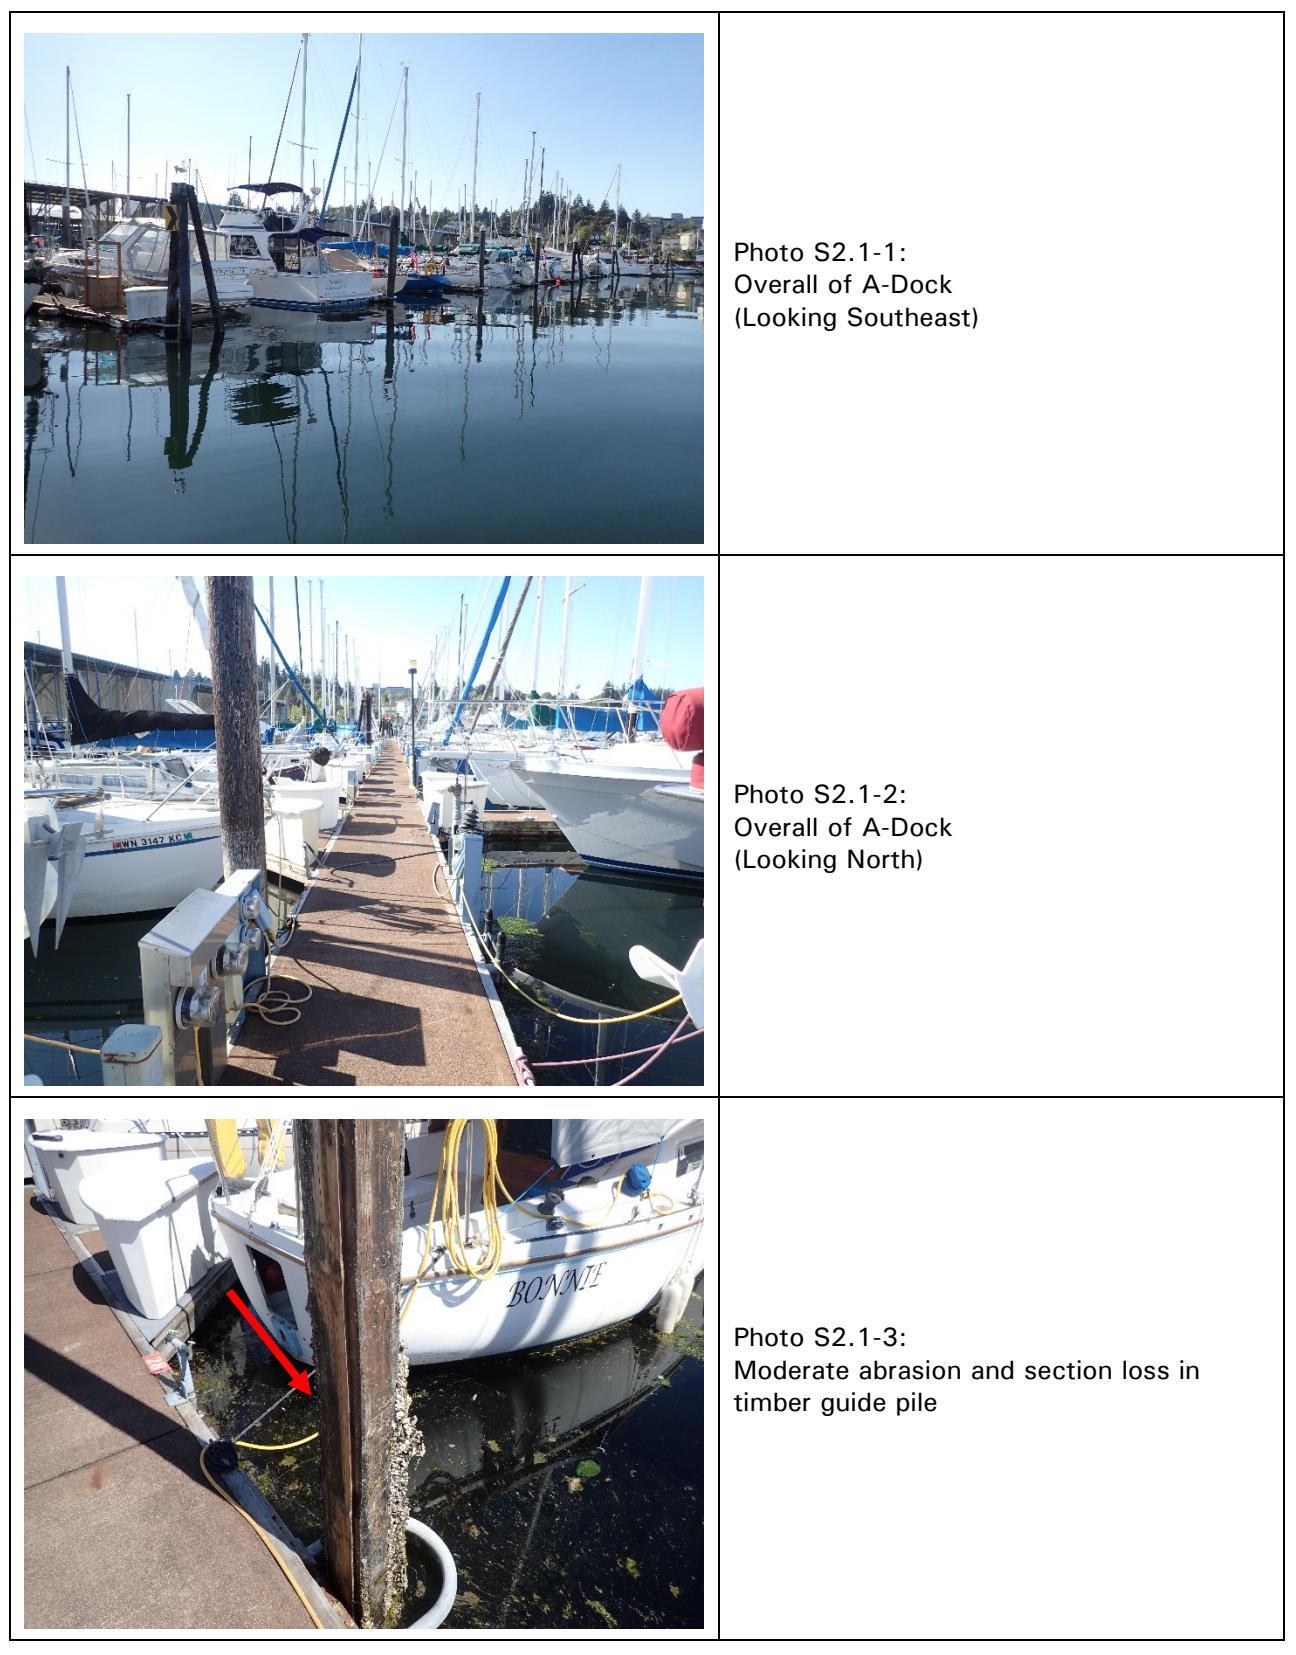
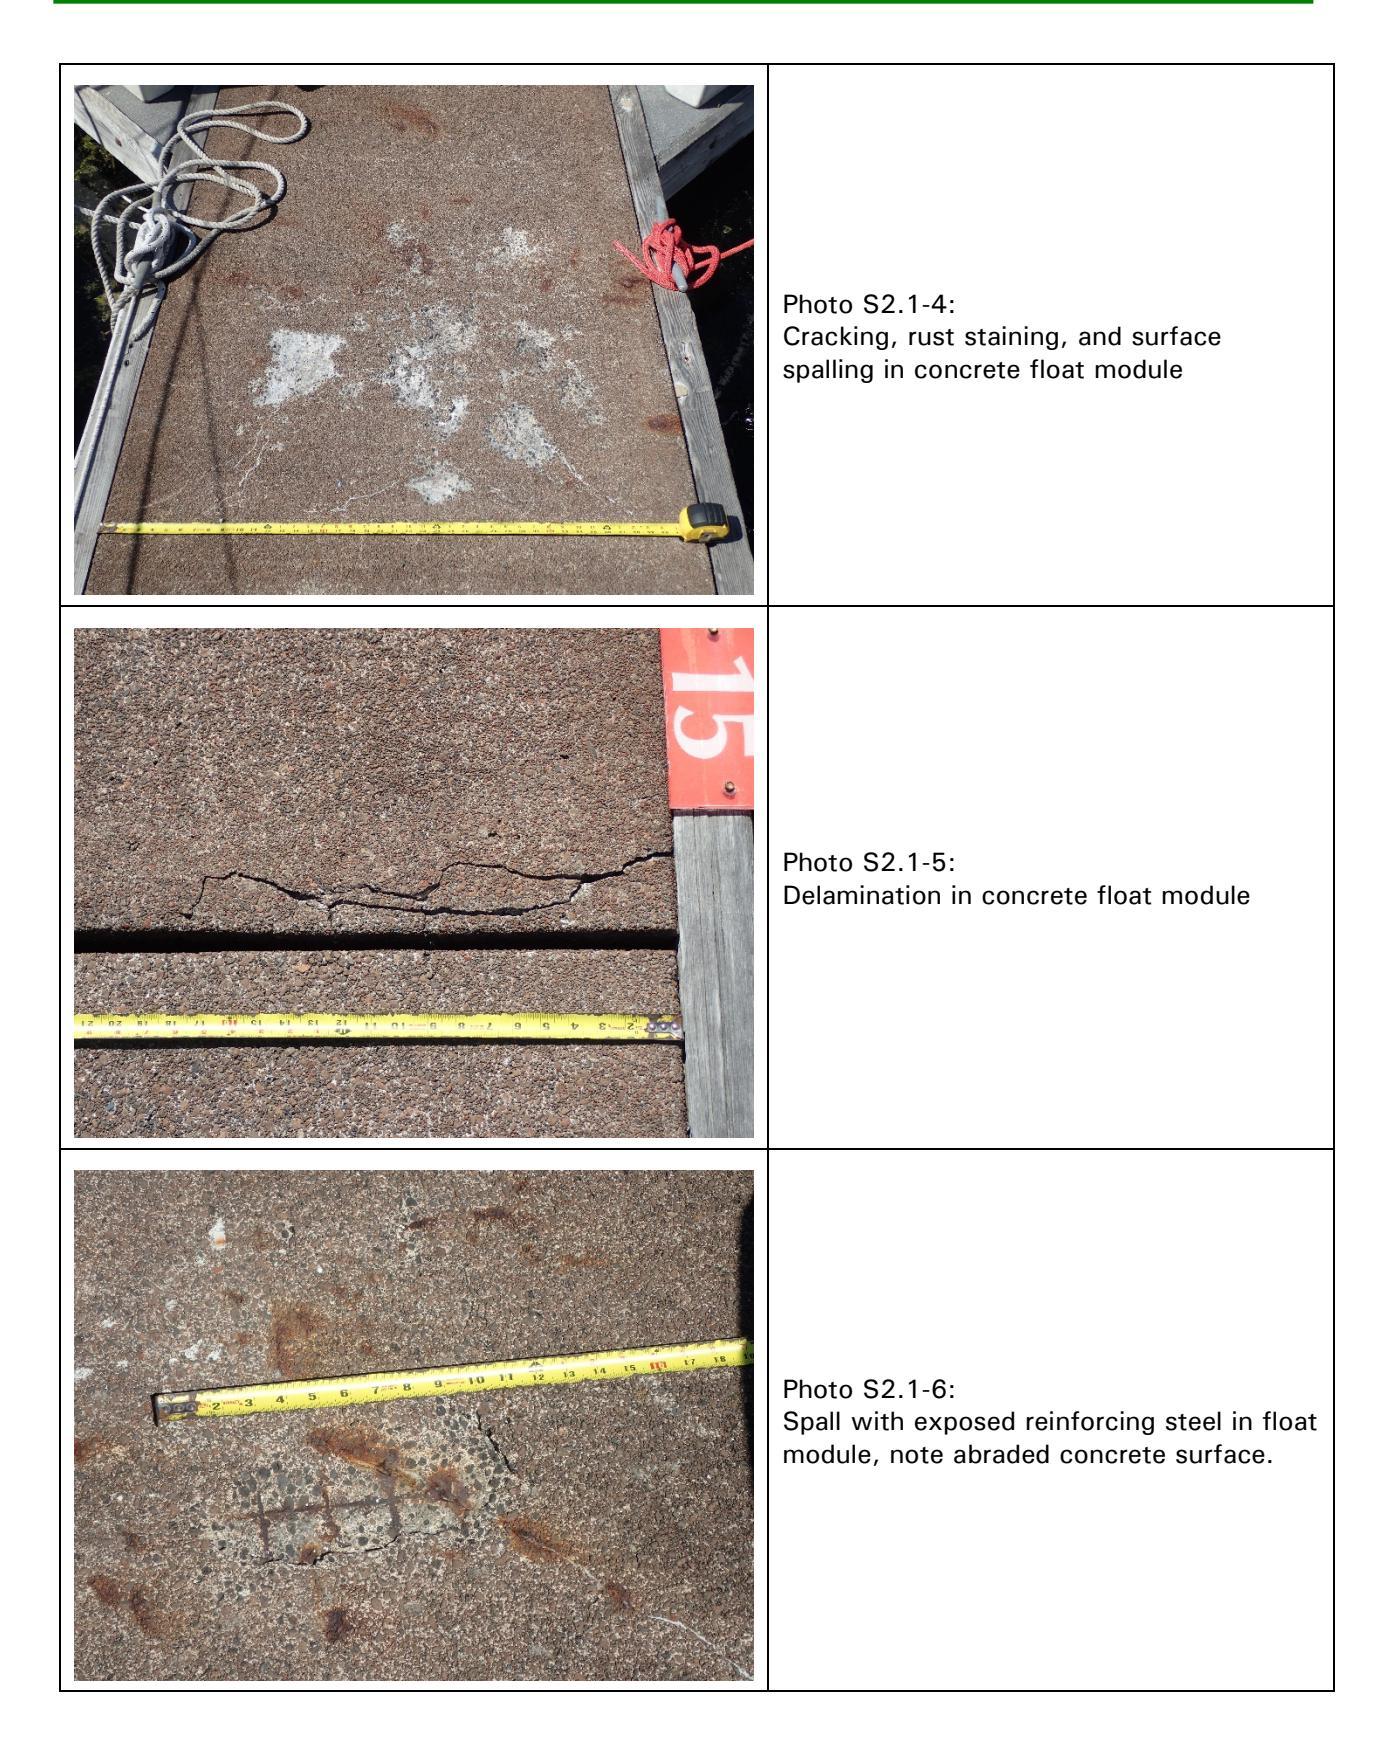
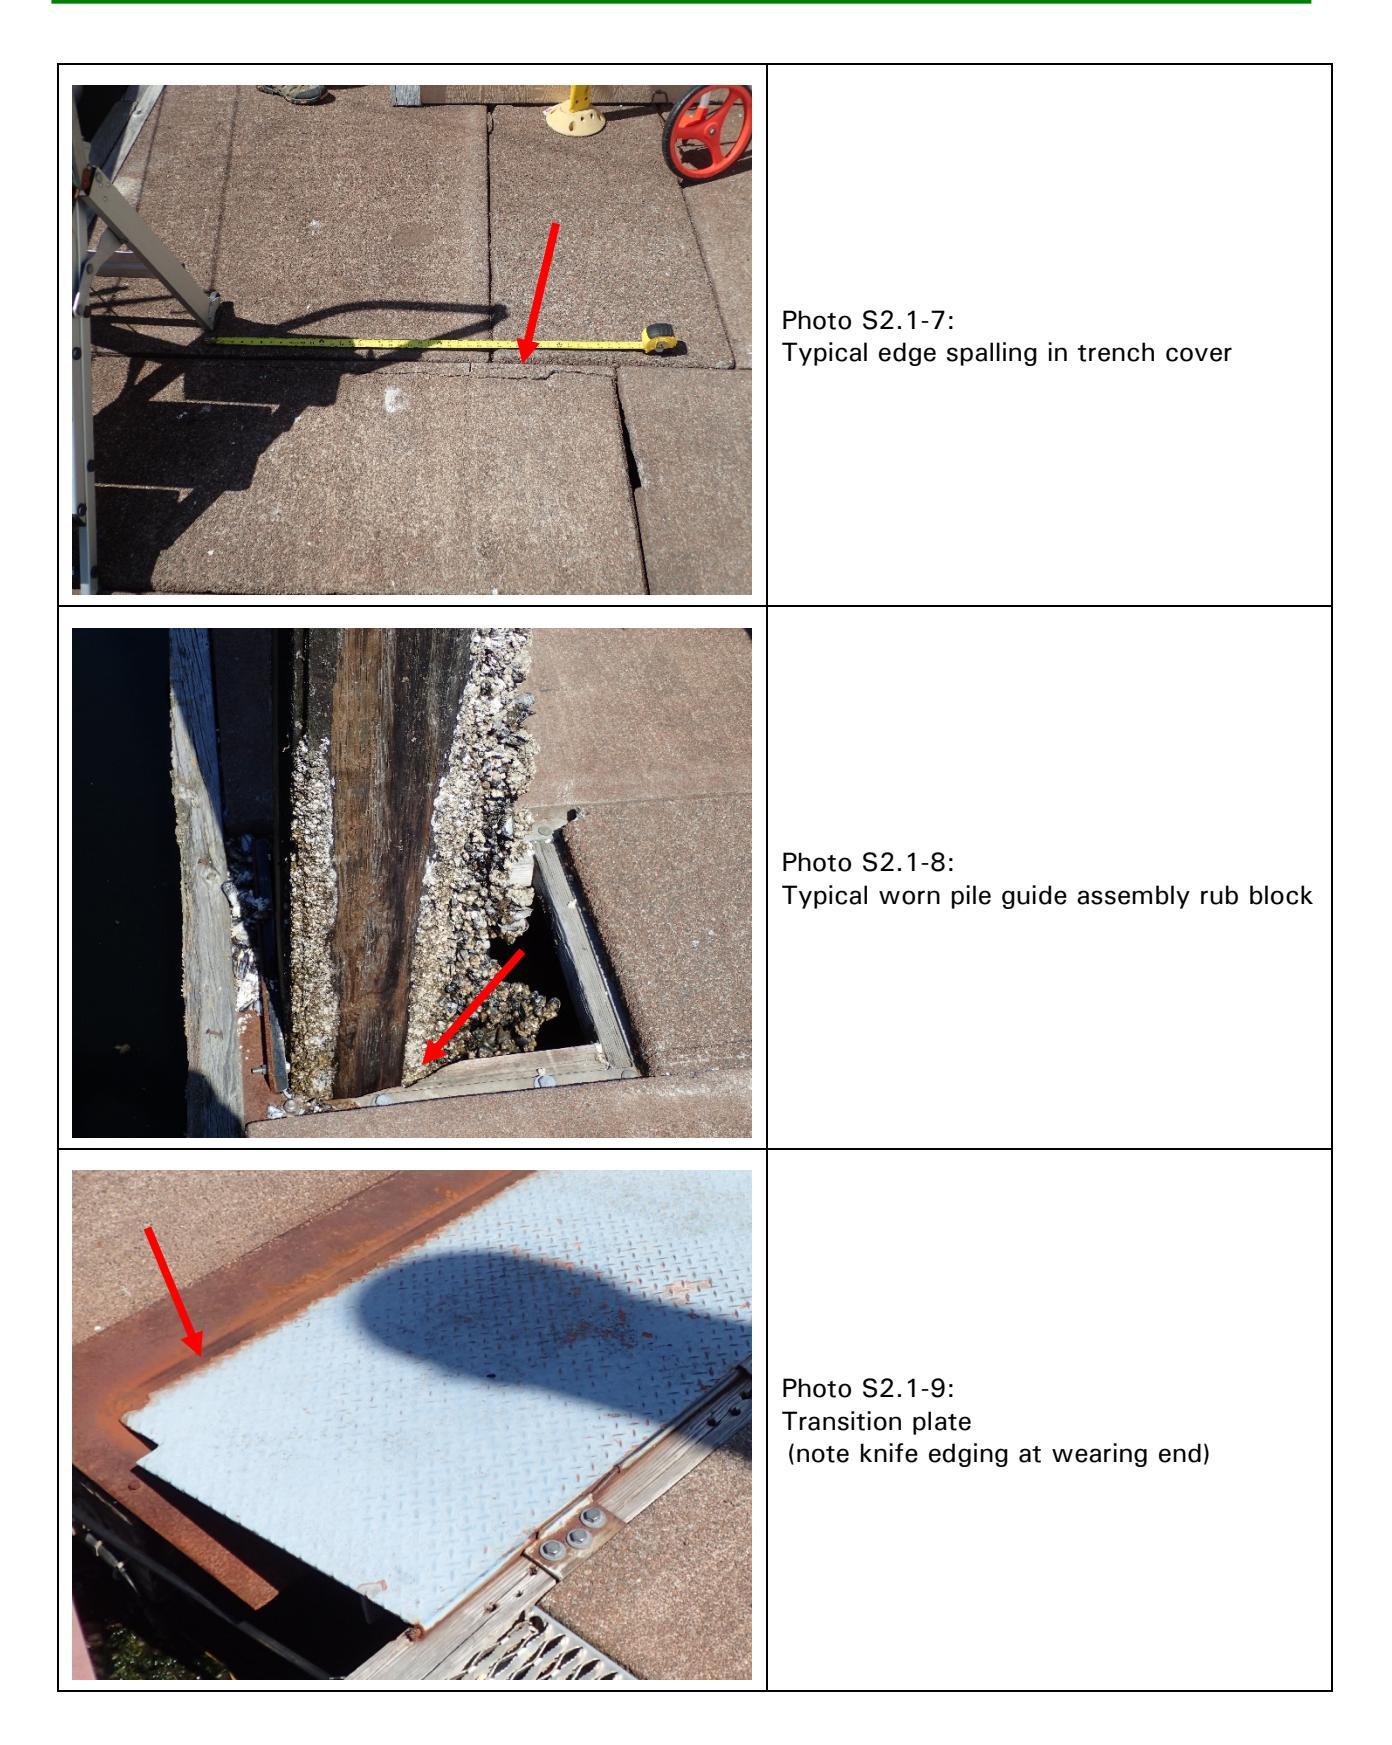
Structural Photographs

The A-Dock is in Fair condition, with a CI of 60 and an Operational Capability Rating of C1 (See Photo 2.1-1 and 2.1-2 for overalls). There are no operational restrictions required for this structure. Each asset was assessed and assigned a numerical Condition Index (CI), ranging from 1 (failed) to 100 (good).

The concrete float modules typically have minor surface scaling up to 1/16" deep, with random edge spalling and abrasion marks up to 1" deep. Three areas of deck delamination were observed up to 2.5'Lx2.5'Wx1/2"D, with associated spalling, rust staining, and random cracking exhibiting efflorescence (See Photo S2.1-4). Two closed corrosion spalls up to 4'Lx3"W were observed, and one 4"Lx10"Wx1/4"D open corrosion spall with exposed and corroded reinforcing steel was observed (See Photos S2.1-5 and S2.1-6). The concrete trench cover panels typically have significant cracks and edge spalling up to 4'Lx2"W (See Photo S2.1-7).

significant section loss was observed. Timber rub blocks are missing from approximately 25% of the external (hoop) guide pile assemblies, and the internal guide pile assemblies located on the

The steel transition plate from the access float to the main float has isolated coating loss and light surface corrosion, with minor section loss observed on the sliding end of the plate (Photo S2.1-9). The hinge connection has minor corrosion and the pin is bent; however, the plate appears to be

access float have worn rub blocks with up to 50% section loss (See Photo S2.1-8).

- Replace missing guide pile assembly rub blocks to minimize abrasion on the piles and guide pile assemblies.
- Resurface concrete float modules, consisting of removal of unsound concrete, cleaning existing reinforcing steel, and placing concrete patch materials.
- Replace cracked and spalled concrete trench covers and investigate using aluminum grid decking as done on other portions of the float system.

- Replace the transition plate providing access between the access float and main float.
- Replace piles with greater than 50% section loss. Steel replacement piles may be considered for long term use, to be incorporated with a new future floating dock system.
- For piles that are replaced, the existing external (hoop) guide pile assemblies should be removed and replaced with recommended guide pile assemblies.
- It can be anticipated that routine maintenance items will be required consisting of tightening loose cleats and replacing guide pile rub blocks. Because of the age and general condition of the float modules, more extensive maintenance items may be required in the near-team consisting of replacing sections of timber wales, replacing tie-rods, completing additional localized concrete spall repairs, and replacing corroded cleats.

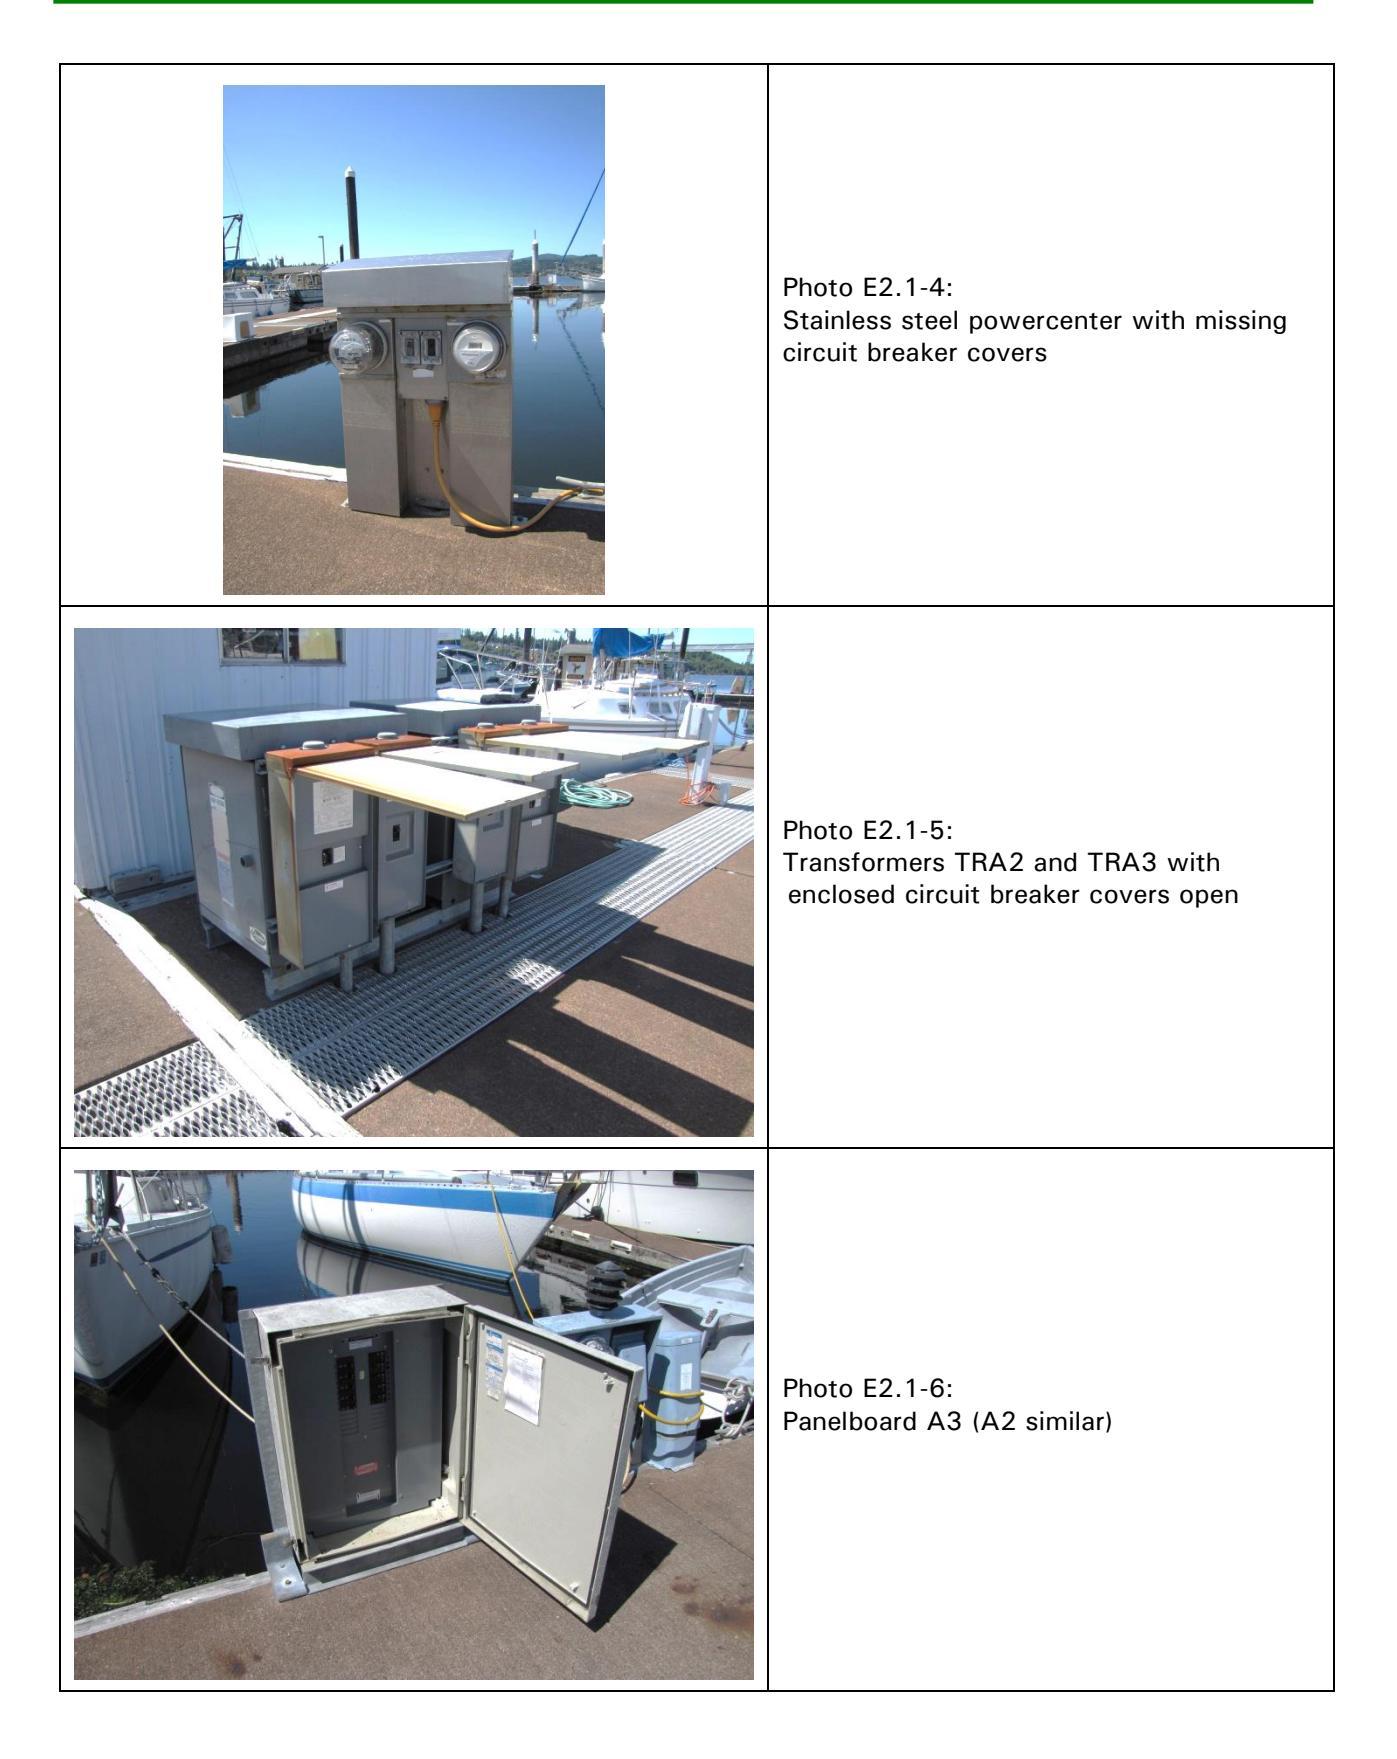
Rust was observed on the non-stainless steel powercenters (See Photos E2.1-1 to E2.1-3). The powercenter serving the T-head slips A01 and A02 is within the horseshoe serving slips A04 and A06 and cables were draped across surface of dock, subjecting the cables to possible mechanical damage and posing a tripping hazard. Per NEC 400.8, flexible cords are not permitted where subject to physical abuse.

Photo E2.1-1: Typical A dock powercenter
Photo E2.1-2: Typical A dock powercenter
Photo E2.1-3: Typical A dock powercenter and light pole

- Replace missing circuit breaker covers
- Replace rusted circuit breakers

- Relocate powercenter from A04/A06 to T-head A01/A02 or provide some way for power cords to reach berths without subjecting cords to possible physical damage
- Provide GFCI protection for all power on dock
- Remove or relocate all electrical connections less than 12 inches above the deck

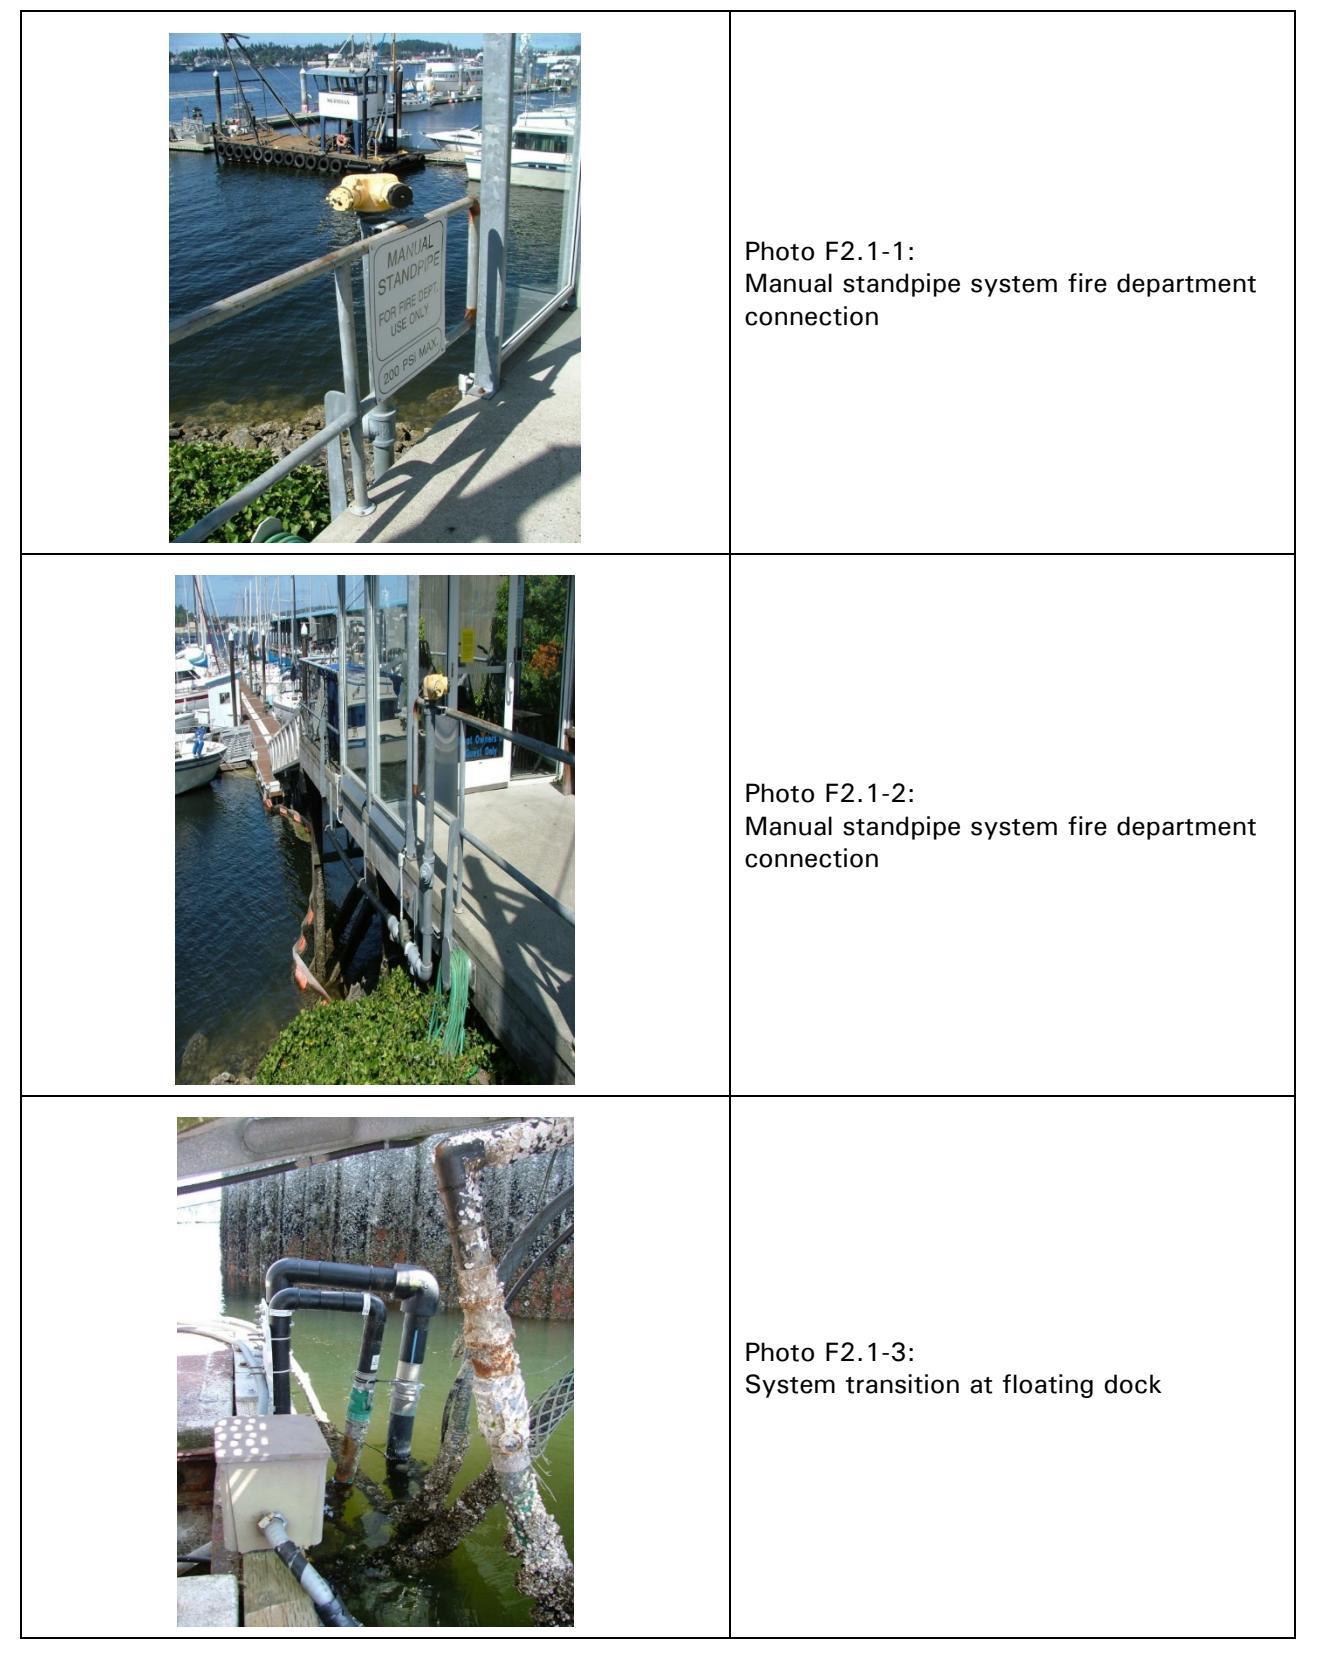
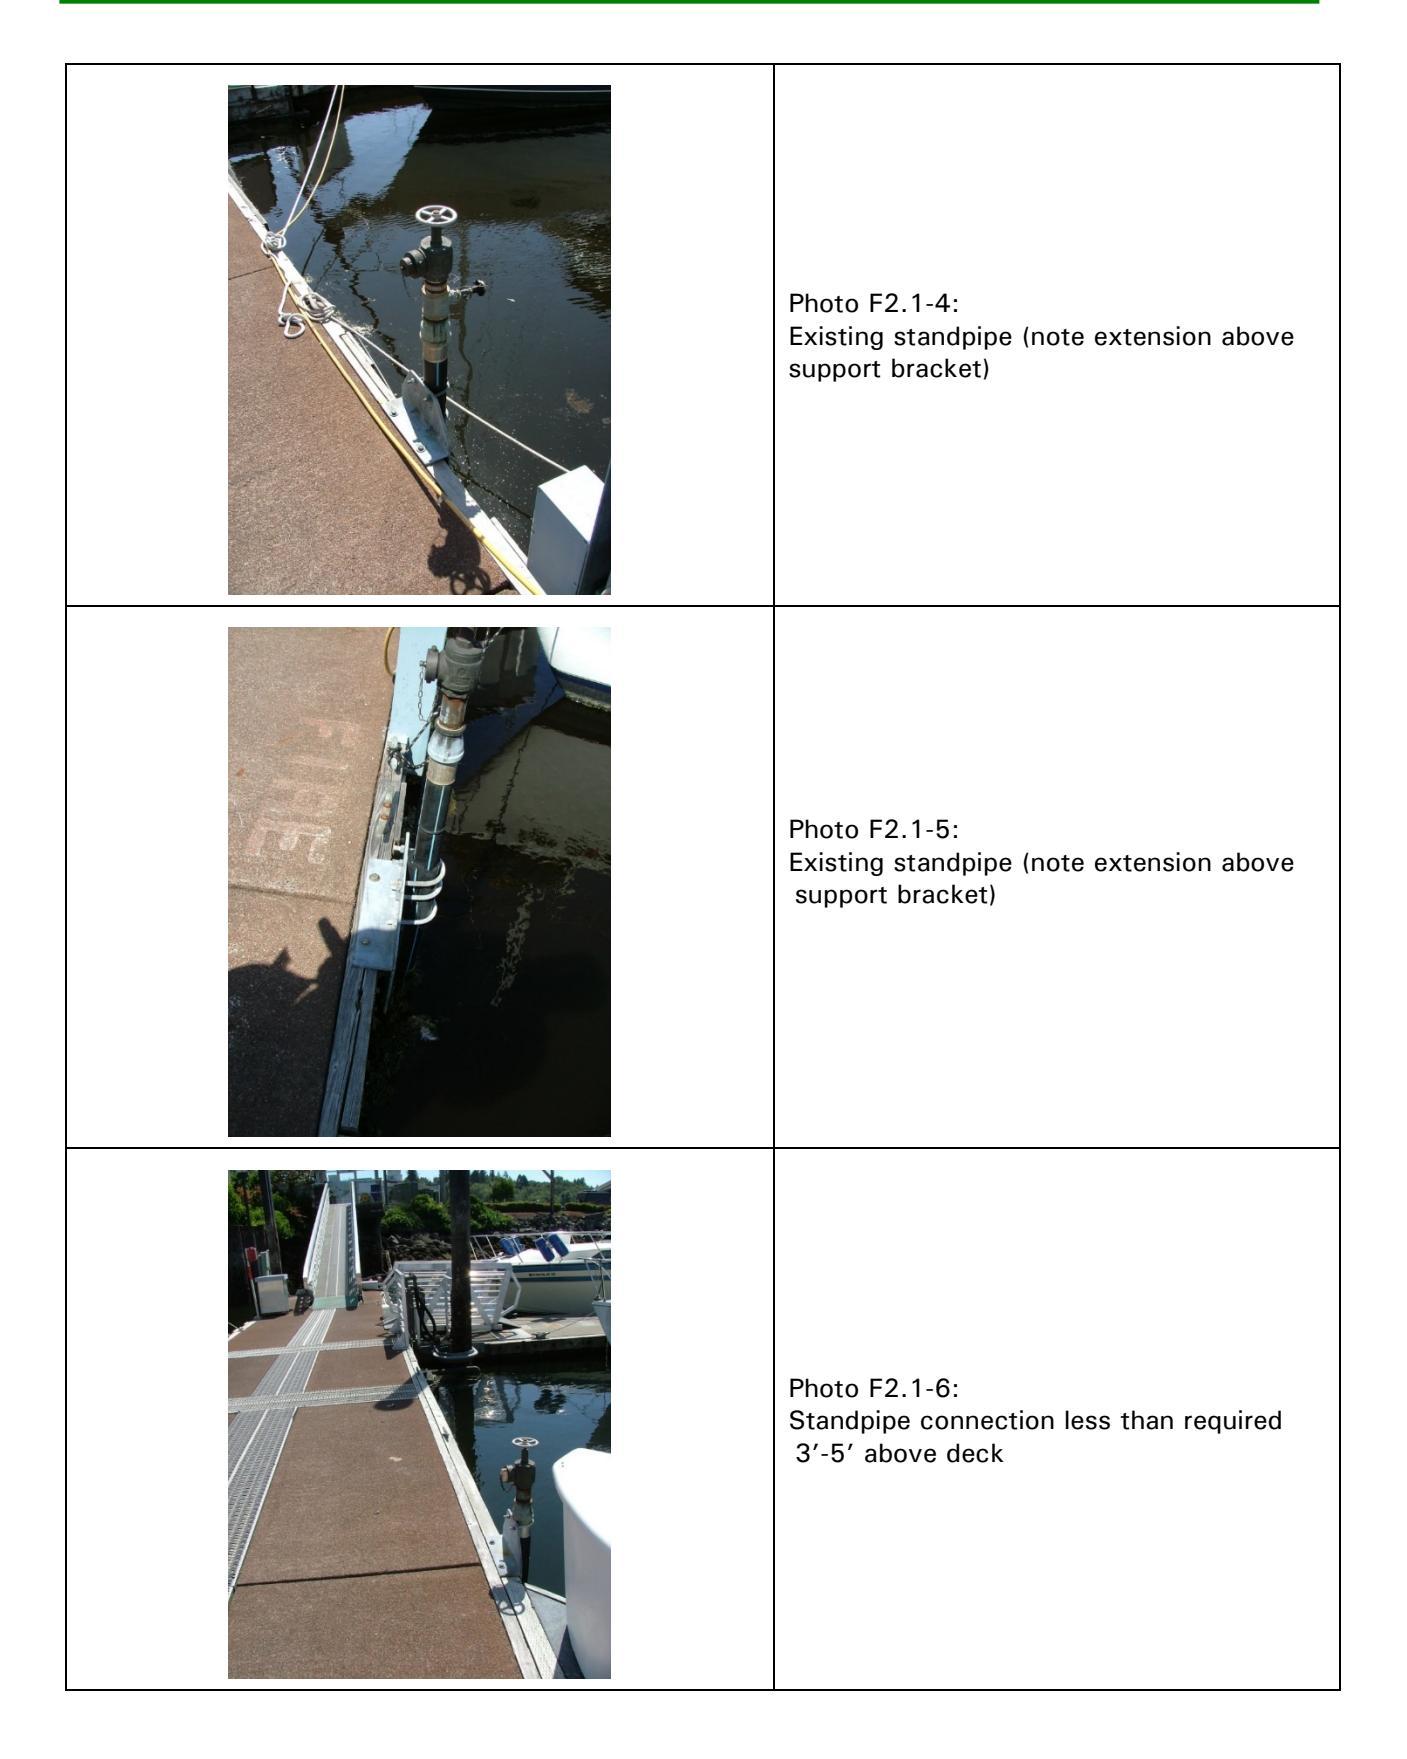
Fire protection Photographs

Fusion-welded High Density Polyethylene (HDPE) piping is installed for most of the fire protection piping system, with unsupported piping resting in the water near the dock. Black HDPE potable water piping (with blue stripe) was used for this installation, and appears to be in good condition. Flexible hoses at the ramp also appear to be in good condition.

Galvanized standpipes (5 total) are in satisfactory condition, but are corroded at threaded fittings and wherever galvanizing does not exist on the piping. The manual standpipe fire department connection is located near the top of the ramp (See Photo F2.1-1 and F2.1-2). HDPE piping extends from the water level to above the dock and connects to galvanized piping and fittings with bronze standpipe valves and hose connections. Some of the standpipes are not well supported (HDPE piping extends above the pipe support to the standpipe valve), but appear to be rigid enough to make fire hose connections (See Photos F2.1-4 and F2.1-5). There is a potential risk that a fire on the dock could melt exposed plastic piping at one of the standpipes and disable the standpipe system. The first standpipe hose connection is less than the required 3' - 5' above the dock (See Photo F2.1-6).

- Replace HDPE piping to standpipes above the dock level with galvanized piping from the valve to just above the water line. This will minimize potential piping damage during a fire, where plastic piping would easily melt, and potentially disable the standpipe system. It will also provide a rigid point for making fire hose connections at the standpipes, as well as allow all of the standpipe valves to be mounted at the same elevation.
- In addition to required NFPA 14 testing of the system, we also recommend the Port of Bremerton have the local Fire Department review the standpipe locations and assure fire hoses can easily be connected to the standpipes.

- Clean and paint rusted surfaces at galvanized piping components where not indicated to be replaced with new standpipes.
- Support the HDPE piping at the elbow-to-flexible pipe transitions below the ramp to minimize stress at the 90-degree fittings. A bracket could be attached to the existing pipe supports and provide reinforcement for the elbows.
