REQUEST FOR QUALIFICATIONS #03-23-30020

Update to the Port Orchard and Bremerton Marinas 10-Year  
Capital Improvement and Maintenance/Repair Programs report

## Port Orchard and Bremerton Marinas 10 Year Capital Improvement and Maintenance/Repair Programs

Final Report: 31 October 2017

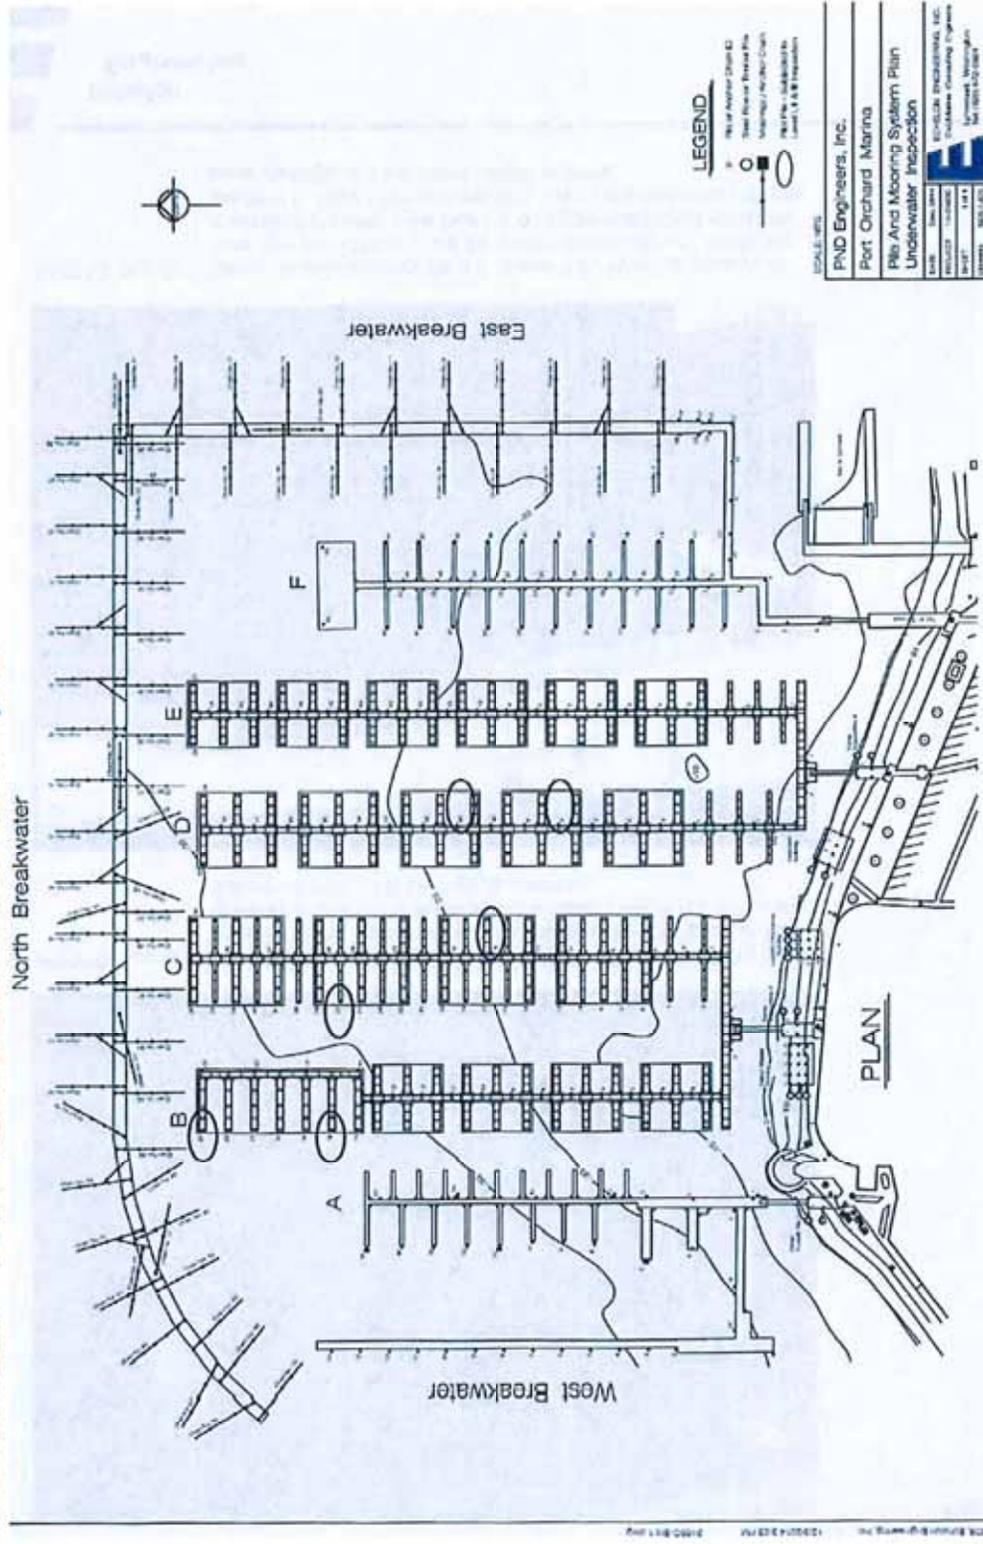
# Attachment 1 – Port Orchard Marine As-Built Layout

**PND Engineers, Inc.**  
 Port Orchard Marina  
 Pile And Mooring System Plan  
 Underwater Inspection

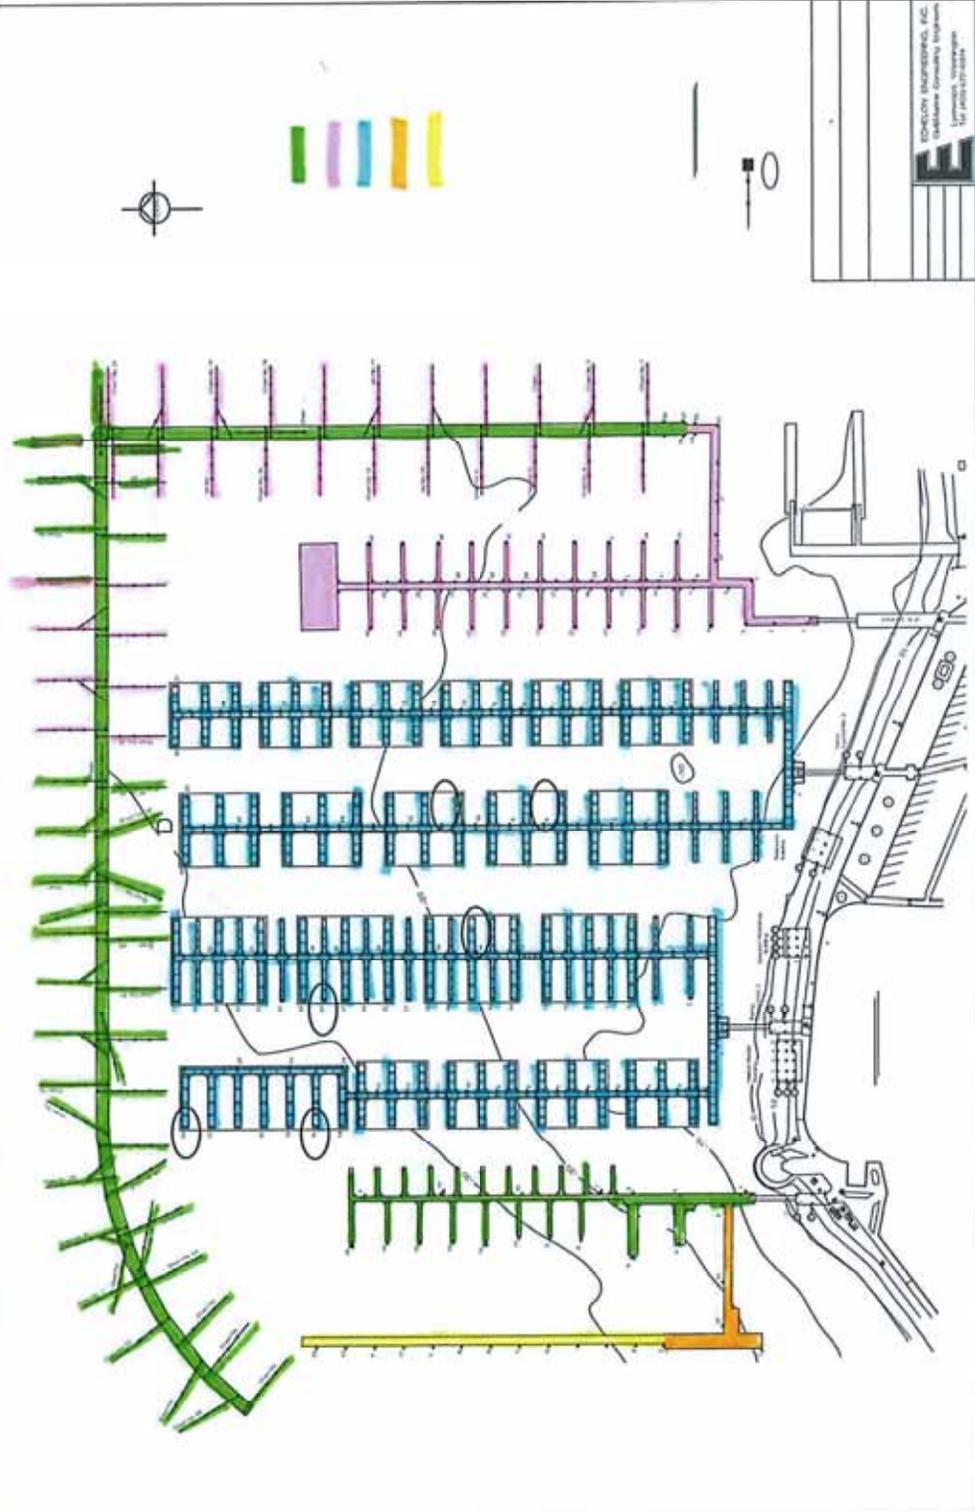
# Attachment 2 – Port Orchard Marina – Graphical History

The original construction of the shore-side wharf structures that house the port office, the laundry/workshop building, and the restrooms consisted of timber piles supporting timber superstructure and wood-framed buildings. Several rounds of maintenance repairs have been conducted to damaged timbers using steel pile posts repairs, bracing and replacement steel superstructure members. The ramp support structures No. 1, 2 and 3 are also constructed using timber piles and superstructure. The piles supporting the buildings and ramps are identified in a standard grid format with the bents identified alphabetically and pile rows identified numerically as indicated in the graphic in Attachment 2.

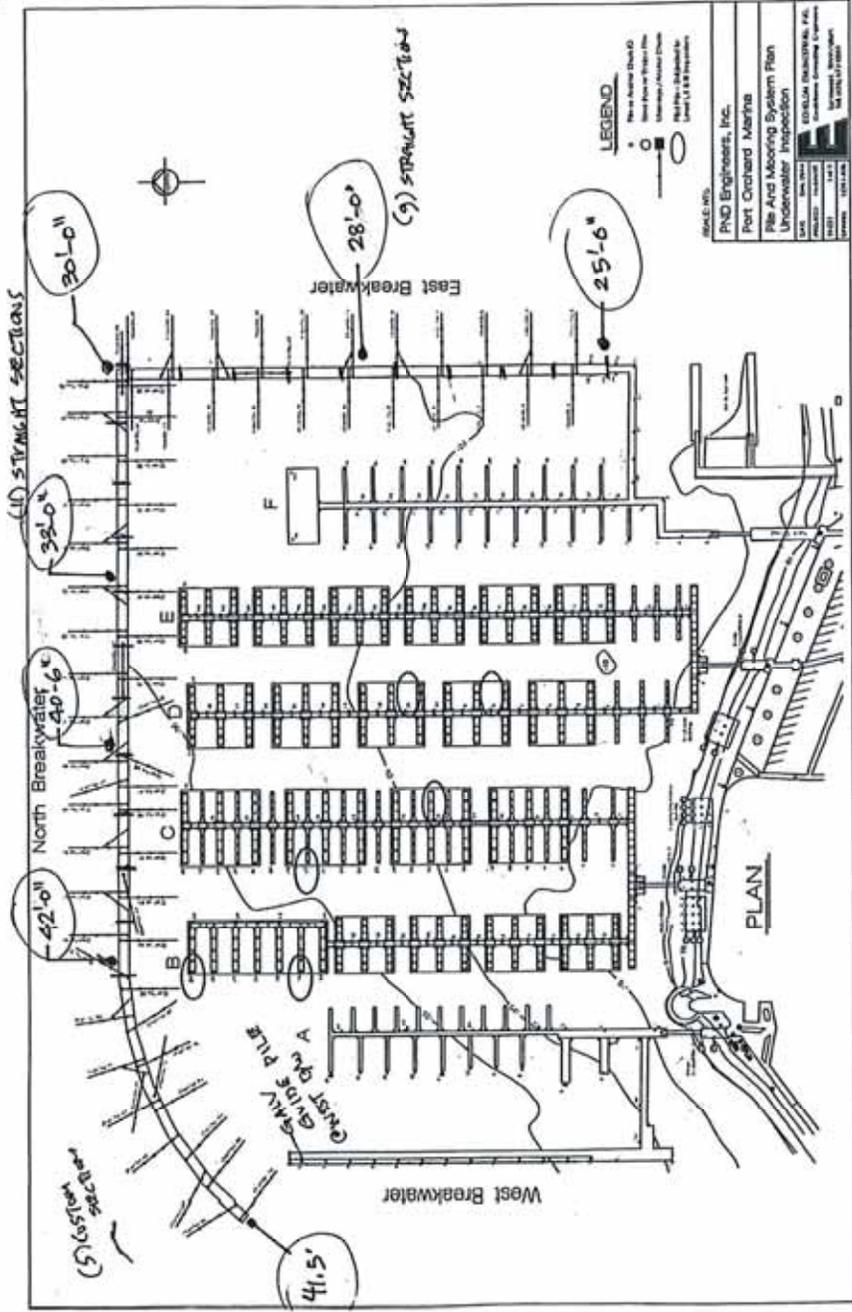
# Attachment 5 - PO Depth readings - 7/28/17

READINGS @ 7/28/17 11:00 AC 7.3 - 7.4 TDZ

The consideration of this new breakwater replacement alternative required a review of the bathymetry data for the Port Orchard Marina. The state of and trending of the bathymetry for this marina remains a concern, since there do not appear to be any records documenting bathymetry readings for the marina area over time. The concern being that there is no way to be sure if certain areas are silting up (perhaps in need to consideration for dredging) or getting deeper, which would affect the design of any mooring system, including guide piles. In order to complete a concept design on the newly recommended guide piling system, a series of simple depth soundings were obtained and are shown in Attachment 5.
