Port Orchard Marina  
Underwater Inspection of Marine Facilities  
707 Sydney Parkway, Port Orchard, WA 98366

Prepared by SDS Consultant  
Seattle Diving Services, LLC  
November 2018

# Underwater Inspection of Marine Facilities – Port Orchard Marina

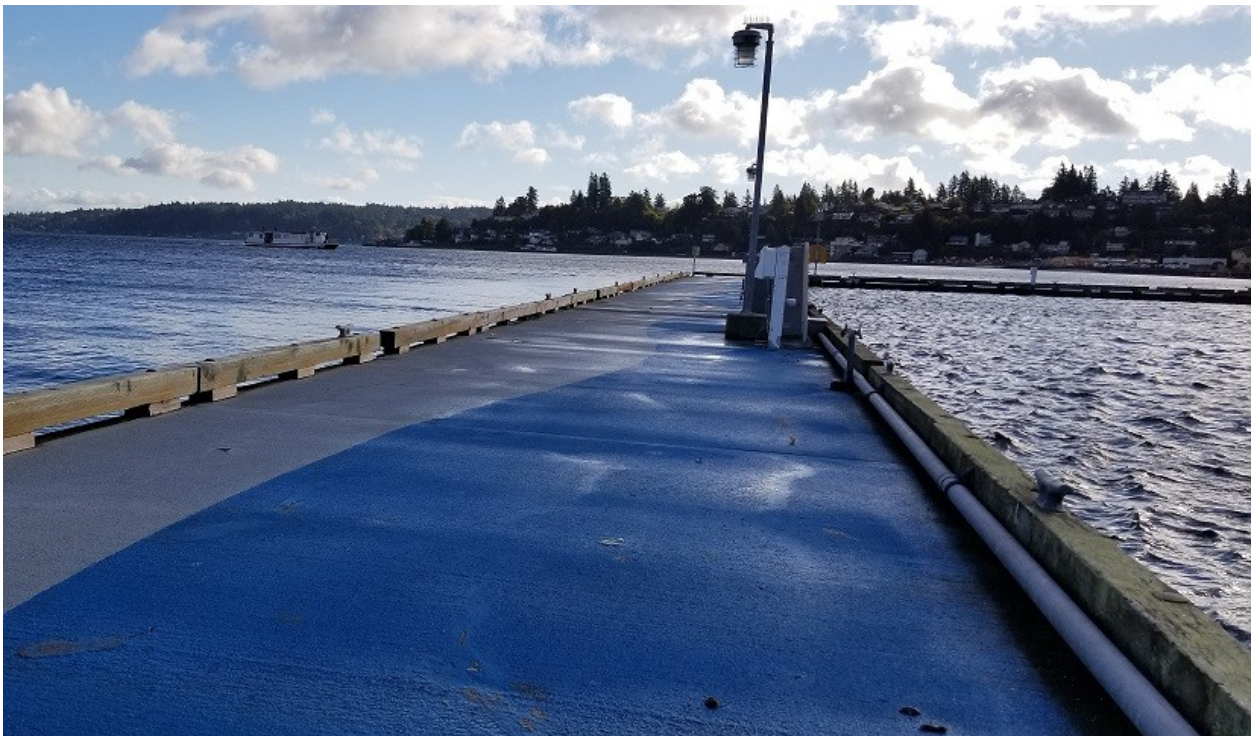
The floating breakwater, associated mooring system, connections, and cathodic protection are generally in overall Fair condition with localized areas of moderate to advanced deterioration. The structures are generally covered in heavy marine growth. Representative areas were cleaned using hand tools for closer examination. The photos within this report provide a visual representation of the typical underwater conditions and deterioration.

The floating breakwater was observed to be in general overall satisfactory condition. Heavy marine growth covered the majority of the breakwater's surface. However, no cracking, spalling, severe corrosion, major damage, or deterioration due to over stress was detected during the inspection.

Floating breakwater mooring lines were found to be in overall Fair condition with localized areas of moderate deterioration. Heavy marine growth covered the majority of the mooring lines. However, the growth was minimal enough to conduct an adequate level I inspection and determine anode & mooring line condition. (See Photo1) .Mooring line numbers 11, 20, 54, 68, & 70 were all observed to have advanced corrosion such as surface rust on the bottom chain and connections. (See Photos 2-3) Recently installed cathodic protection for bottom chain of mooring line number 50 was disconnected on resting on the seafloor. (See Photo 4) No surface corrosion was observed as previously installed anodes appeared to be providing residual cathodic protection but this should be considered temporary.

Mooring line numbers 11, 20, 54, 68, & 70 were all observed to have advanced corrosion on the bottom chain and connections. In-kind rehabilitation would involve one additional anode installed at the top of the bottom chain and include proper cleaning sufficient enough to ensure contact between the bottom chain and cathodic protection. These repairs need to be carried out with moderate urgency. Mooring lines and cathodic protection components should continue to be inspected annually. All anodes 50% or below should be considered for replacement within the next two quarters. Continued annual inspection should be considered for future planning.

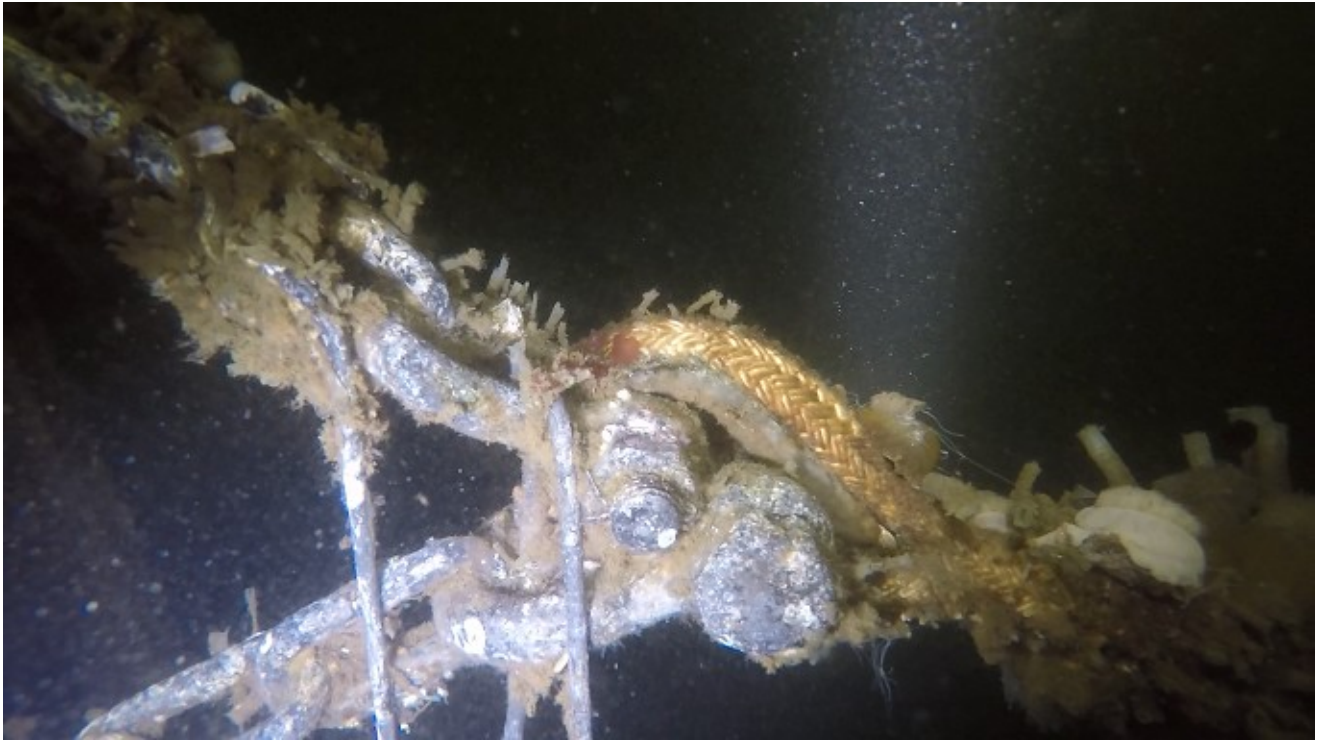
The floating breakwater's bridle chain systems and cathodic protection are generally in overall Fair condition with localized areas of advanced deterioration. The structures are generally covered in heavy marine growth and representative areas were cleaned using hand tools for closer examination. The photos within this report provide a visual representation of the typical underwater conditions and deterioration.

Thirteen bridal chain systems were listed for level II inspection. Fourteen bridal chain systems were found, two of which were disconnected. Mounting brackets for bridle chain numbers 11 & 35 were both subject to advanced deterioration and connection failure. (See Photos 5 & 6) The originating cause behind the failure is suspected to be ordinary wear from the 1" shackle connecting the 5/8" long-link bridle chain to the bracket. Under the influence of waves, currents, and electrochemical corrosion these two components had worn and failed. The lower connection of these bridle chains were still connected to the mooring lines and were found to have advanced deterioration. Early stages of pad-eye wearing was found on bridle chain bracket numbers 19 & 42. (See Photo 7) All other bridle brackets, chains, and associated hardware was in satisfactory condition with minor but typical deterioration. (See Photo 8)

The bridle chain numbers 11 & 35 have brackets that have deteriorated to a point of failure. These brackets and associated bridle chains should be considered for in-kind replacement as soon as possible. New cathodic protection will need to be installed on the bridle chain only.

Bridle bracket numbers 19 & 42 should be considered for replacement within the next year due to typical wear from wave action.

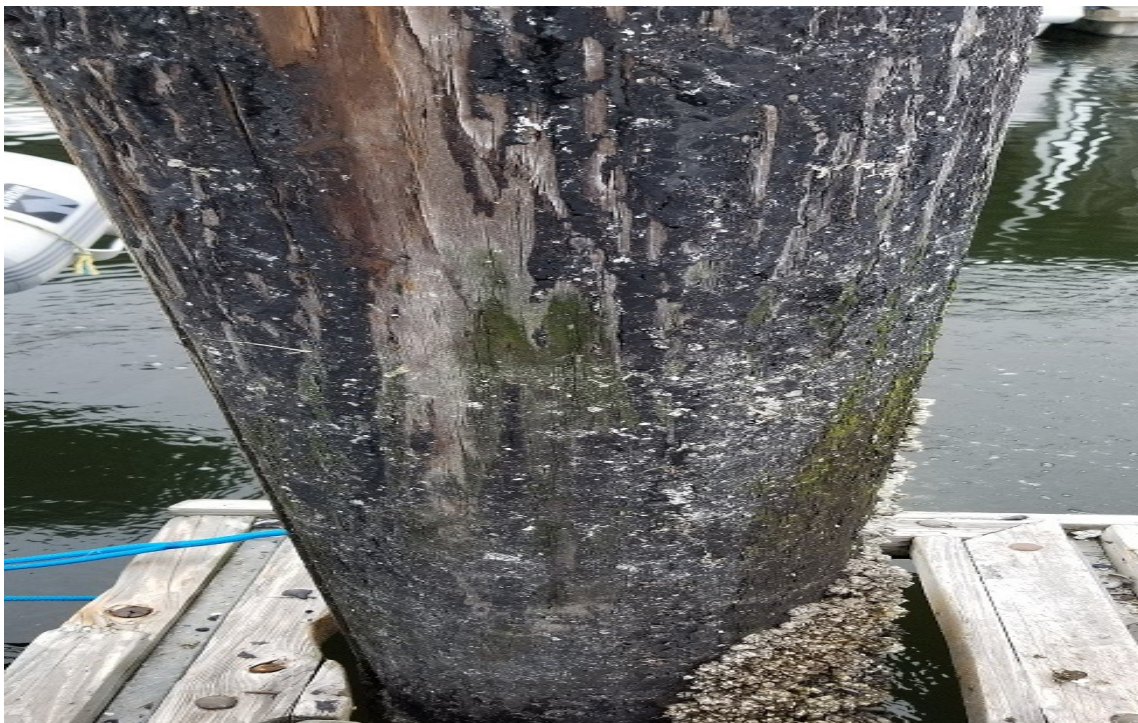
No major defects or deterioration was found, only minor abrasion in the tidal zone cause by the pile guide was noted. Minor deterioration of the creosote coating was detected but is typical. Hammer soundings determined the pile to be in overall sound condition. Physical examination did not detect any rot, borer holes, or major deterioration, only minimal cracking was discovered. (See Photo 9)

Based on our underwater inspection, the underwater condition of this structures is Satisfactory. The deterioration noted in this report is considered minor and no load reductions are required as a result of the underwater structures. The pile was observed to be creosote-treated, it is probably 30 years or older. The detailed inspection determined that the timber mooring pile should not require short-term rehabilitation to provide an extended service life.

No repairs are recommended to the underwater portion of the timber pile. The timber pile is estimated to have approximately 10- 15 years of useful life remaining before replacement or similar repair should be considered.

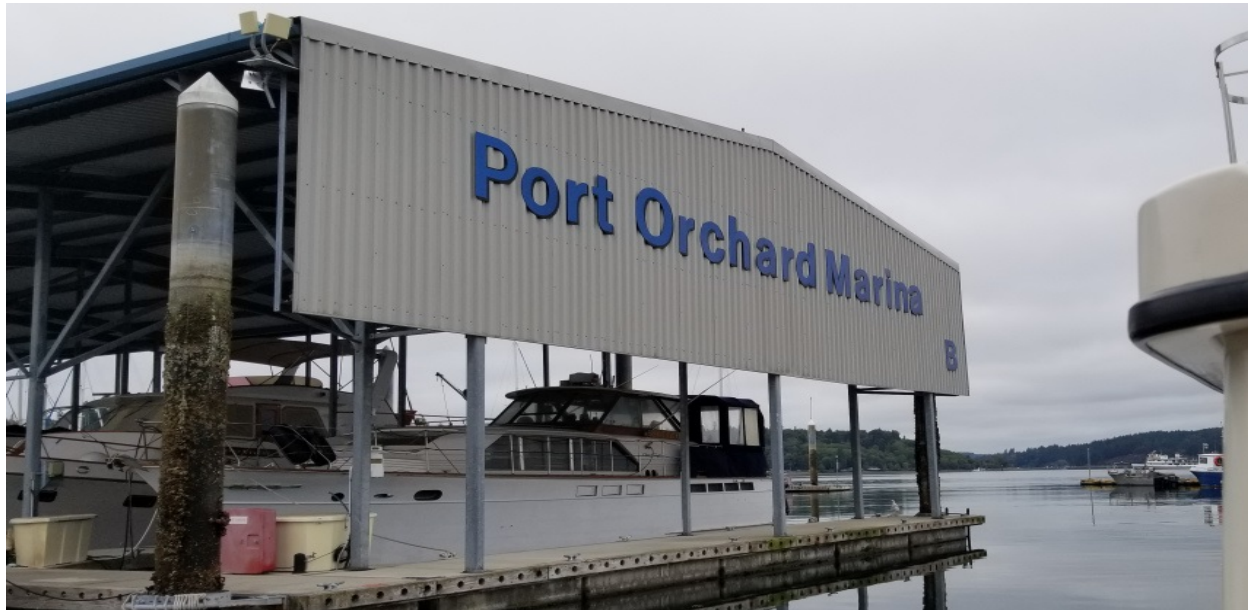
The six pilot piles are generally in overall sound condition with extensive areas of moderate deterioration. The deterioration was most severe in the tidal and submerged zones of the pilot piles. All pilot pilings besides D-32 were observed to have moderate to advanced pitting and surface rust covering any exposed surface area below the low tide line. (See Photos 10-11) Piling D-32 was observed to have typical corrosion which is considered minor, no surface rust was observed. (See Photo 12) All anodes have cathodic protection systems installed. Wire cable sections for anodes on pilings C-16 & 27 had failed, most likely under influence from tide fluctuations. All anodes appeared to be in good condition with a layer of calcium deposits, which is typical. Upon physical examination, anodes instantly crumbled and revealed their true condition to be poor, less than 50% remaining. Pile thickness and corrosion potential readings provided in TABLE 1.

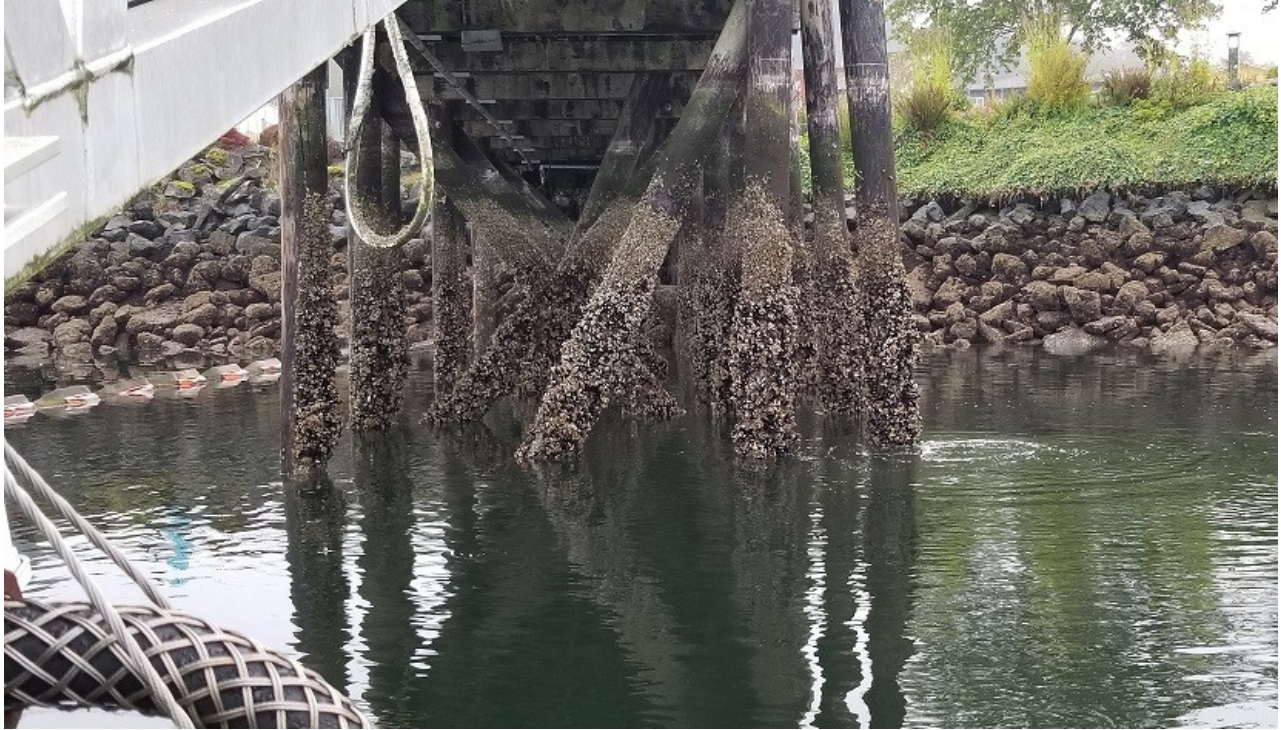
The structures are generally covered in heavy marine growth and representative areas were cleaned using hand tools for closer examination. The photos within this report provide a visual representation of the typical underwater conditions and deterioration. The building and approach dock timber piles and supports are generally in overall sound condition with limited areas of minor defects/ deterioration.
