Underwater Inspection of Marine Facilities  
707 Sidney Pkwy, Port Orchard, WA 98366

Prepared by SDS Consultant  
November 2020

# Harper Pier Underwater Inspection

**Port Orchard Marina**  
707 Sidney Pkwy, Port Orchard, WA 98366

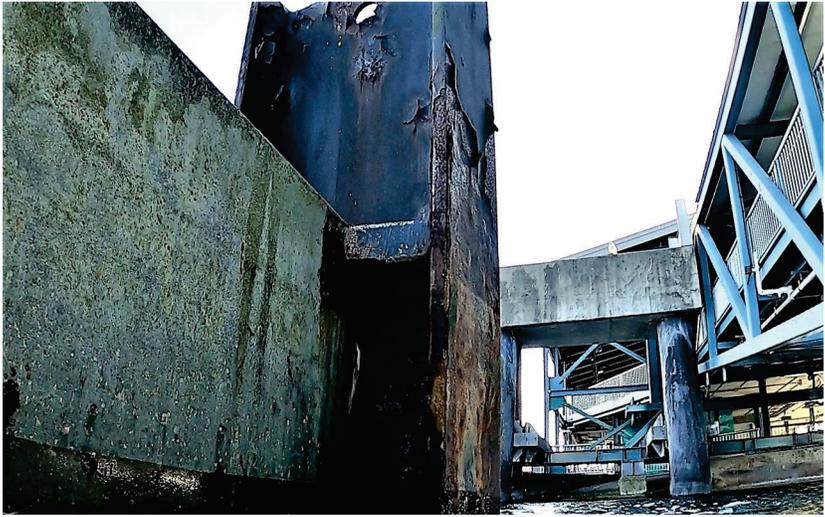
The H-Pilings are in overall fair condition, deterioration was most severe just above the high tide line, in the splash zone. (See Photo 48) In addition, all wall supporting components welded to the H-Pilings were subject to accelerated deterioration. This form of corrosion is common and is caused when two dissimilar and joined together and submerged. One metal will corrode faster than the other and in this case, it is the wall bracing and supports. The H-Pilings themselves have typical-moderate deterioration. (See Photos 49)

Seattle Diving Services, LLC		Photographic log	
Port of Bremerton		South Side Wave Attenuator Wall	Photo 48
<p><b>Client:</b> Port of Bremerton Bremerton, Wa.98337</p> <p><b>Description:</b> Typical H-pile in splash zone, minor surface corrosion and delamination</p>
